Town of Garrett Park

To: Mayor and Town Council
From: Barbara B. Matthews, Town Manager
Subject: Town Hall Renovation
Date: November 12, 2024

Property Condition Review

Garrett Park Town Hall

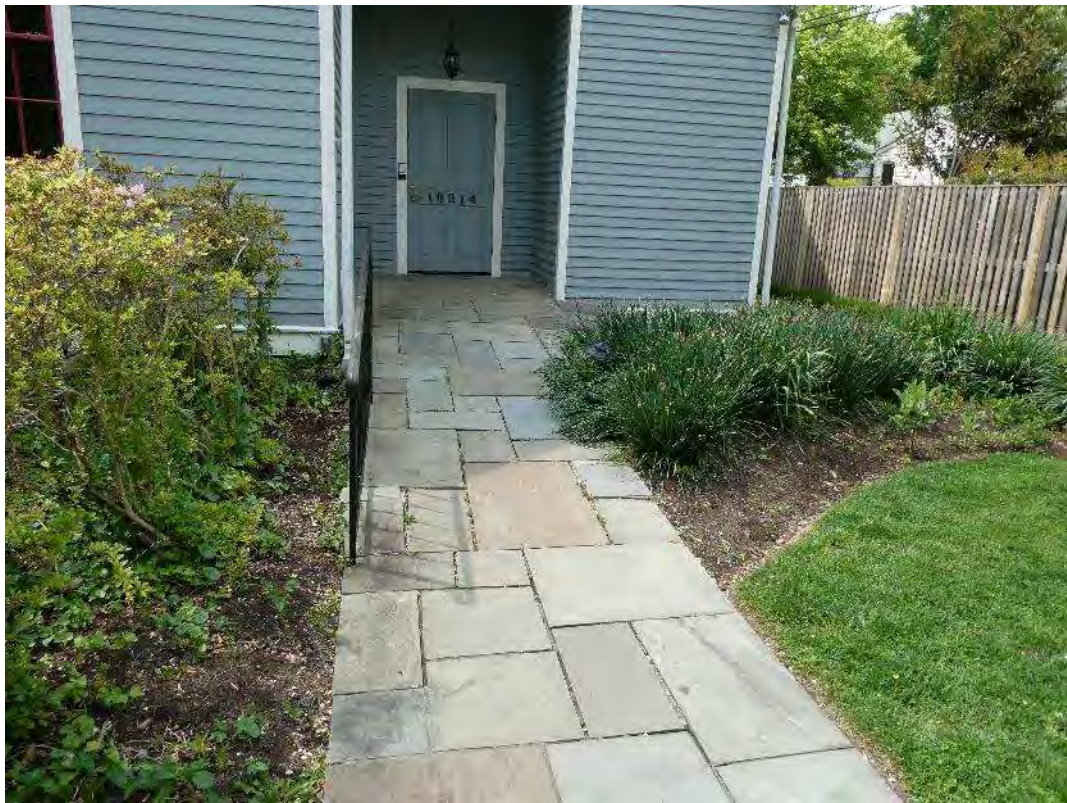
Photograph 1: Ramp at entrance which is not ADA compliant

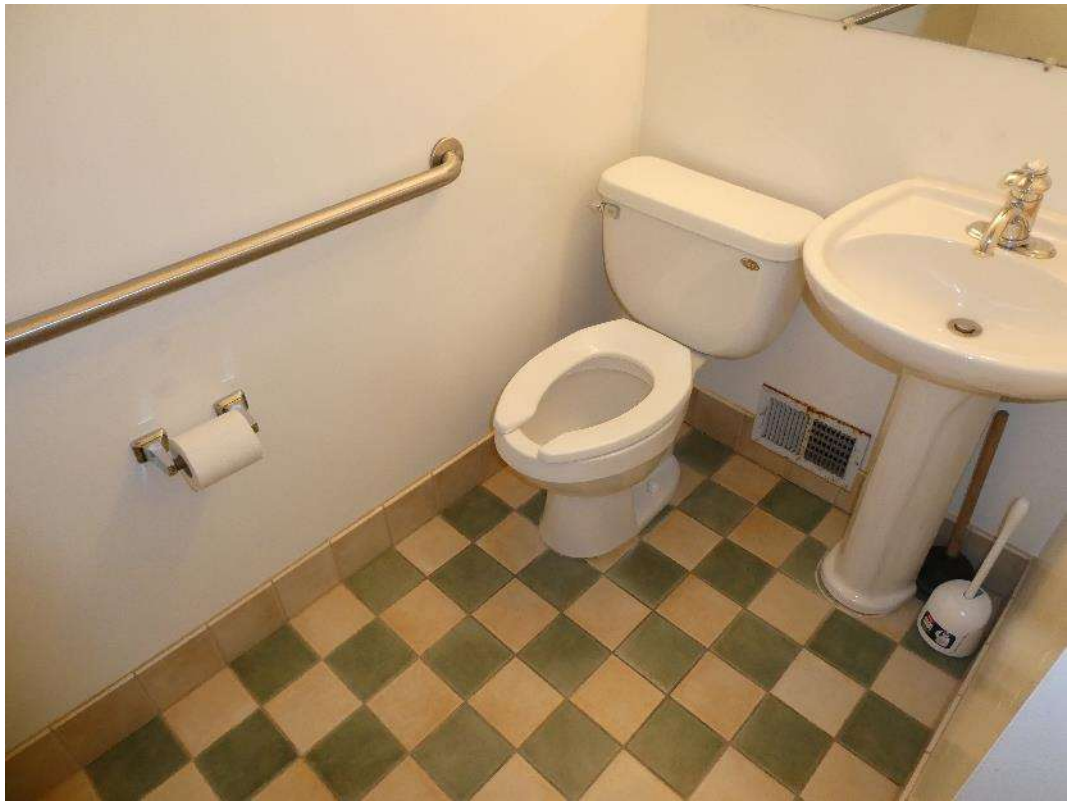
Photograph 2: Non-compliant restroom

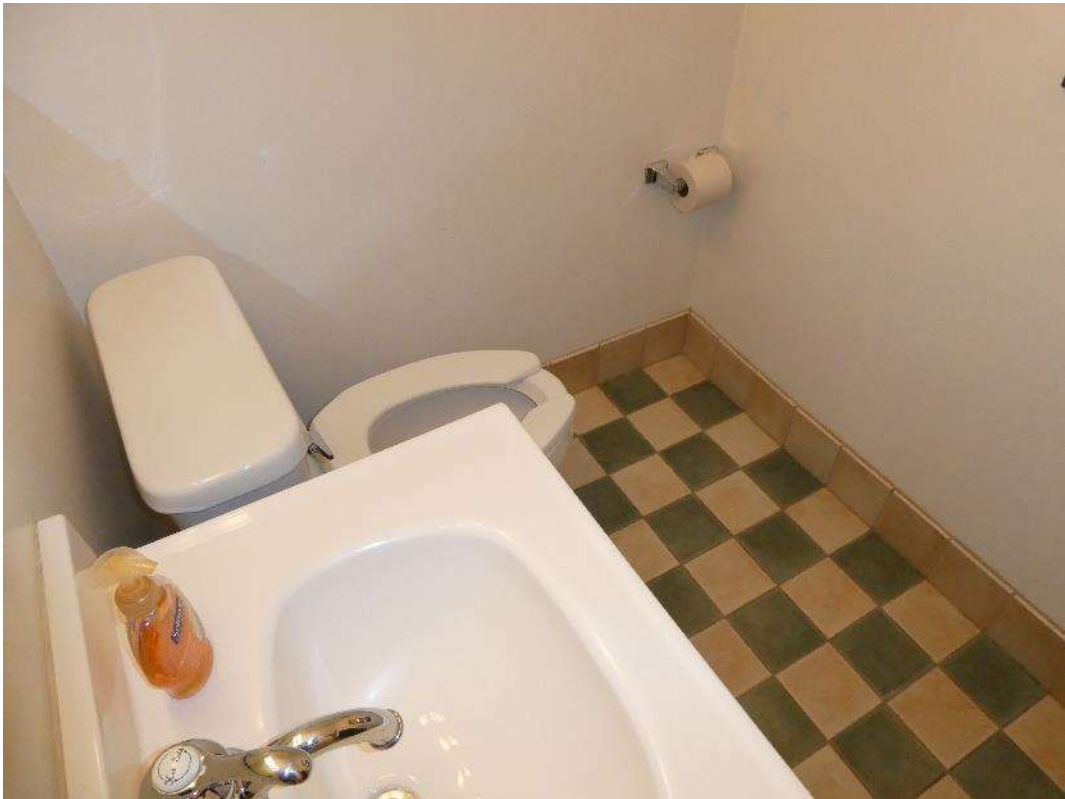
Photograph 3: Non-compliant restroom

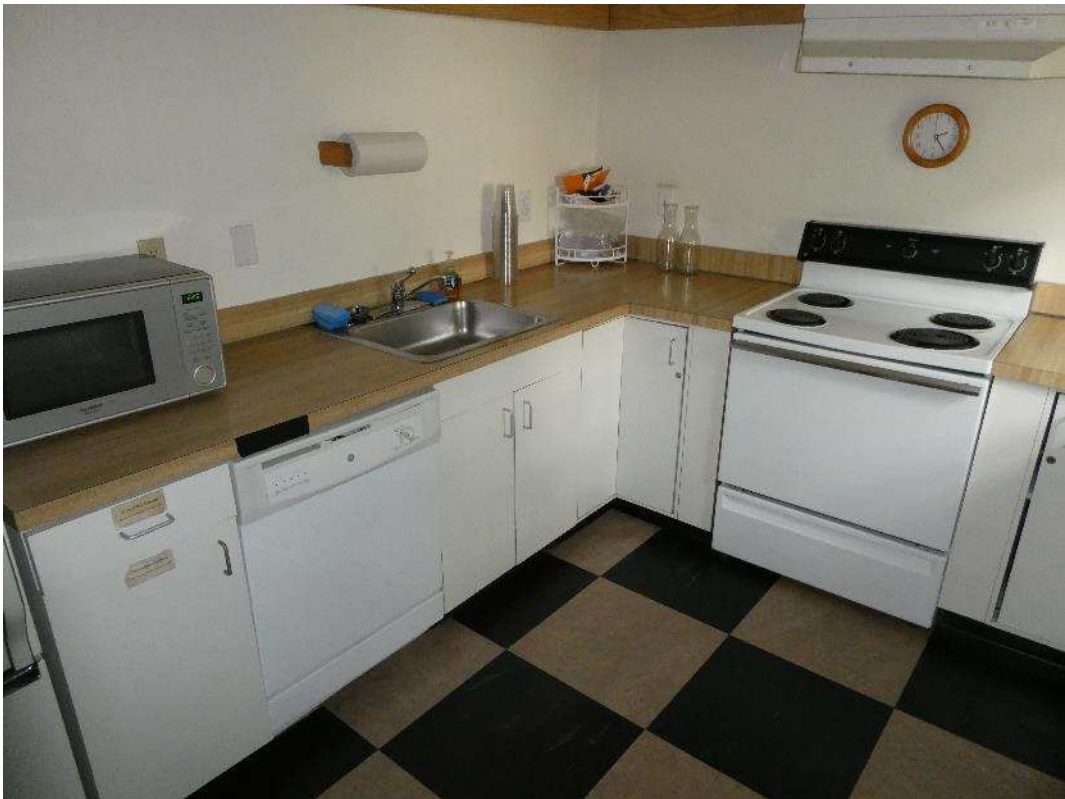
Photograph 4: Non-compliant kitchen

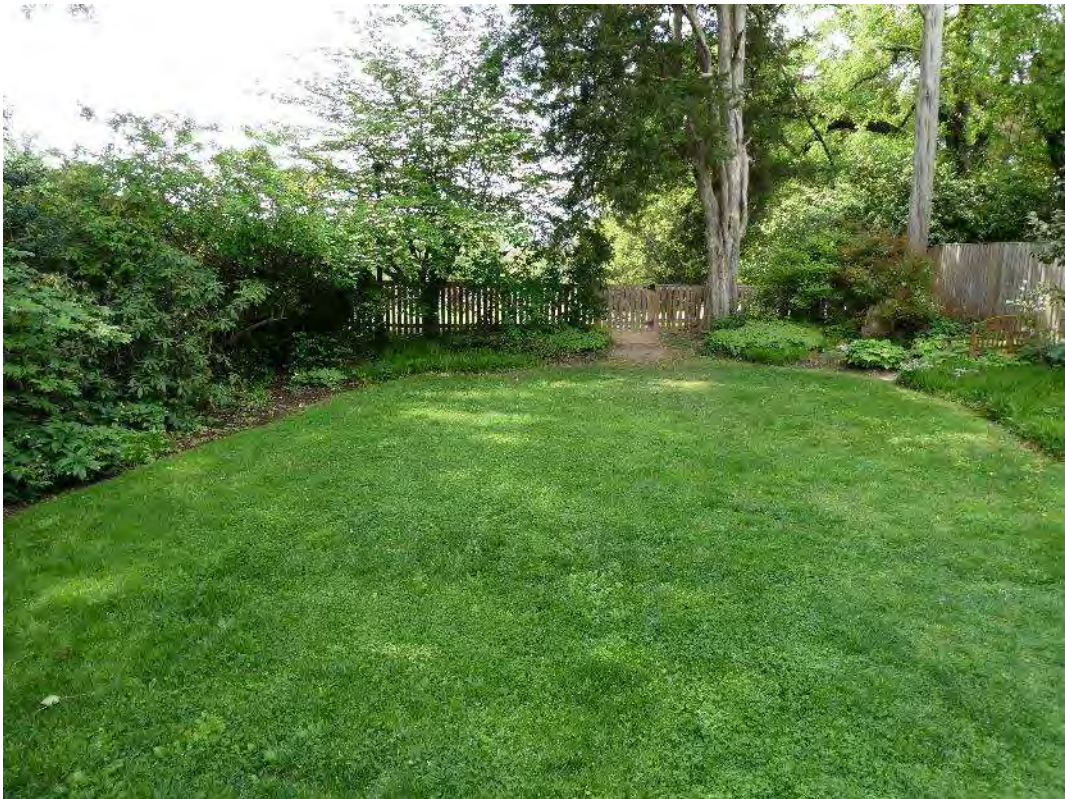
Photograph 5: Rear yard area and fencing

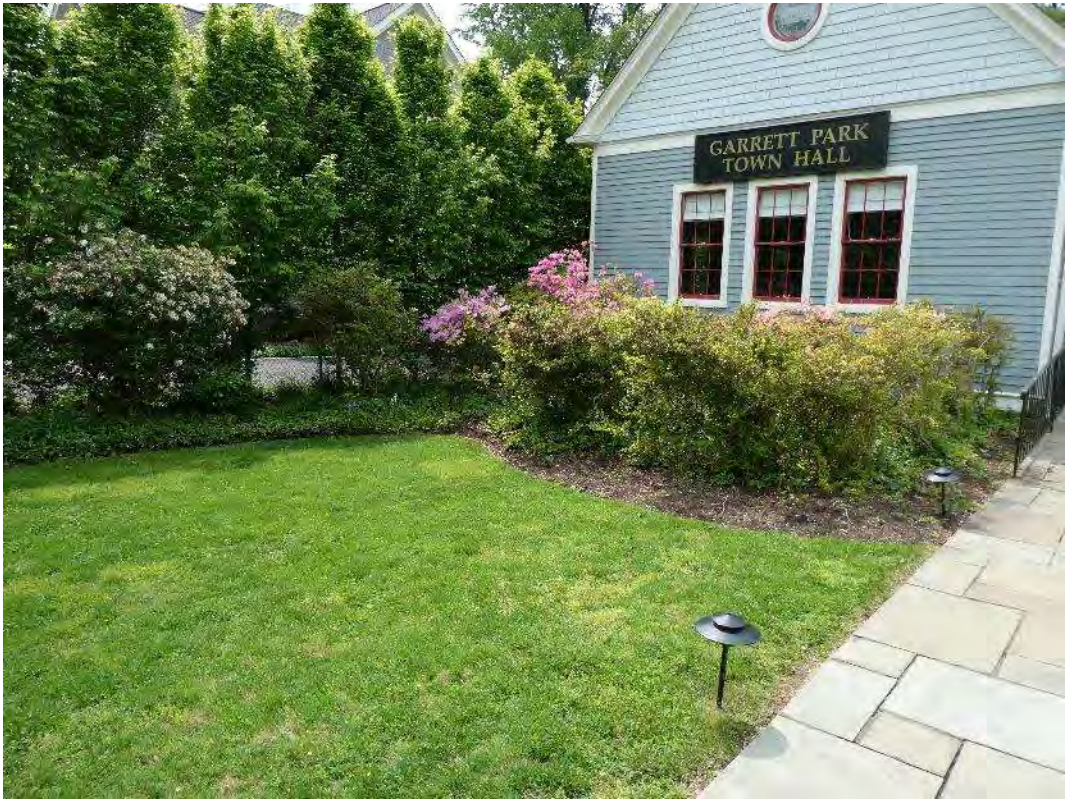
Photograph 6: Front yard area

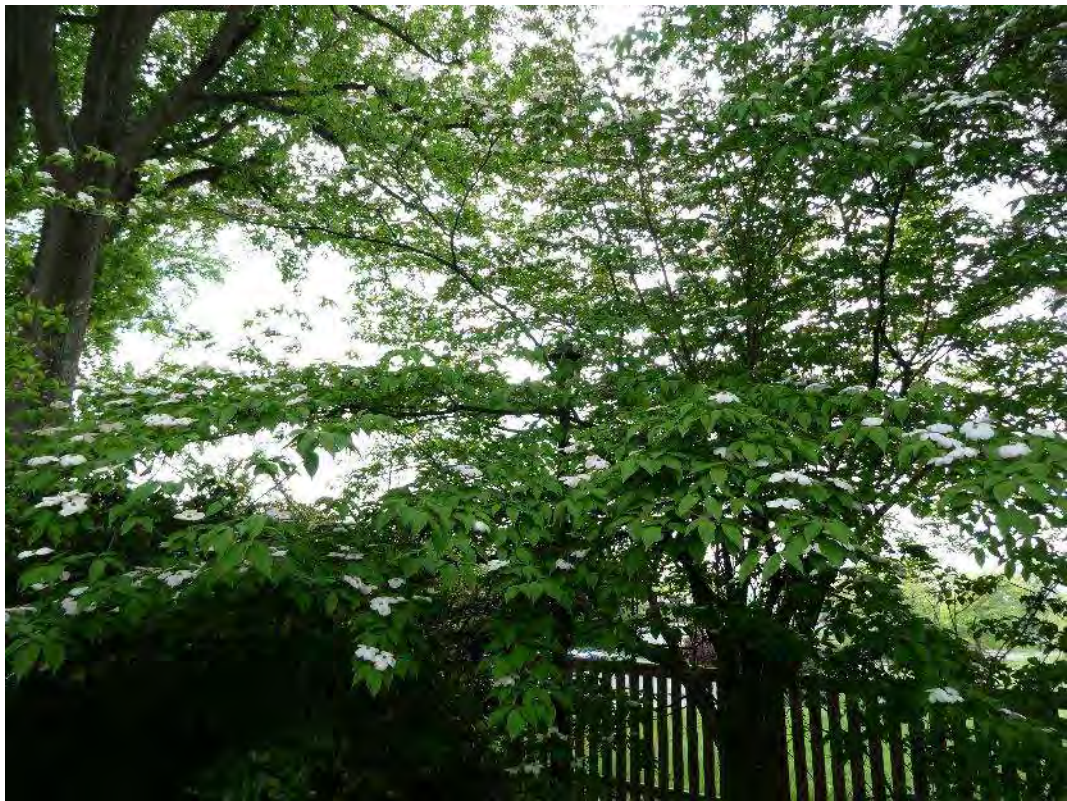
Photograph 7: Rear fence and abandoned/damaged streetlight

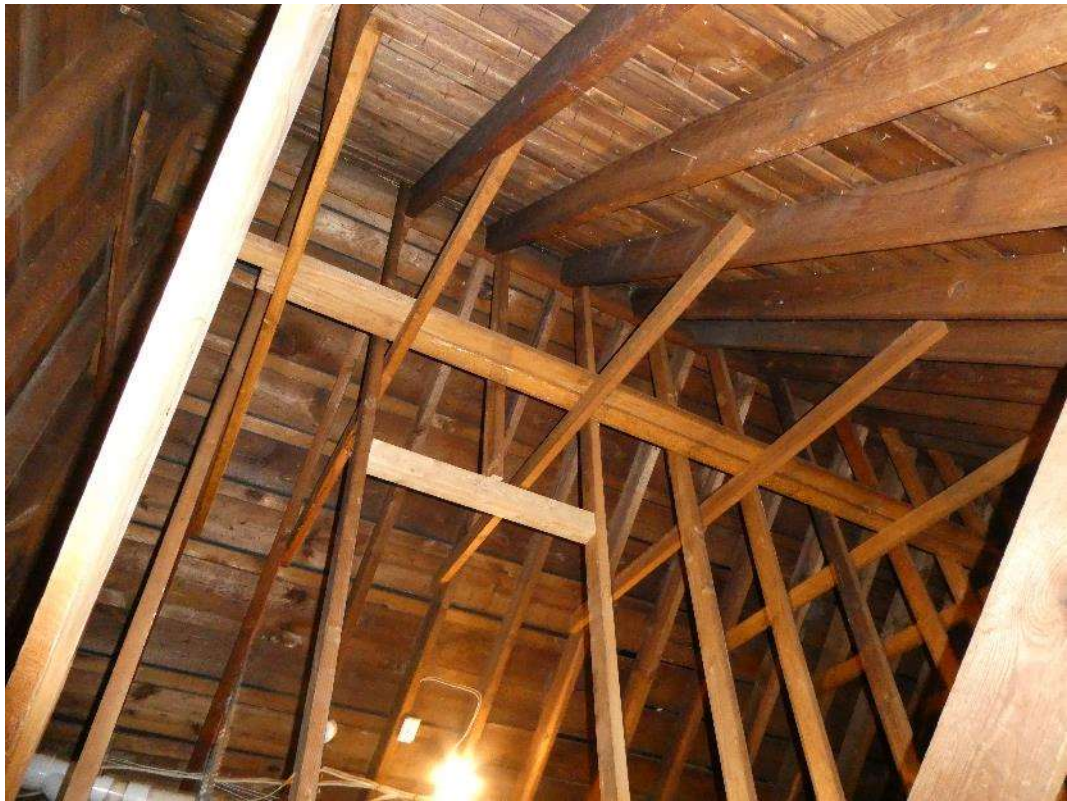
Photograph 8: Roof structure of original building, viewed from attic

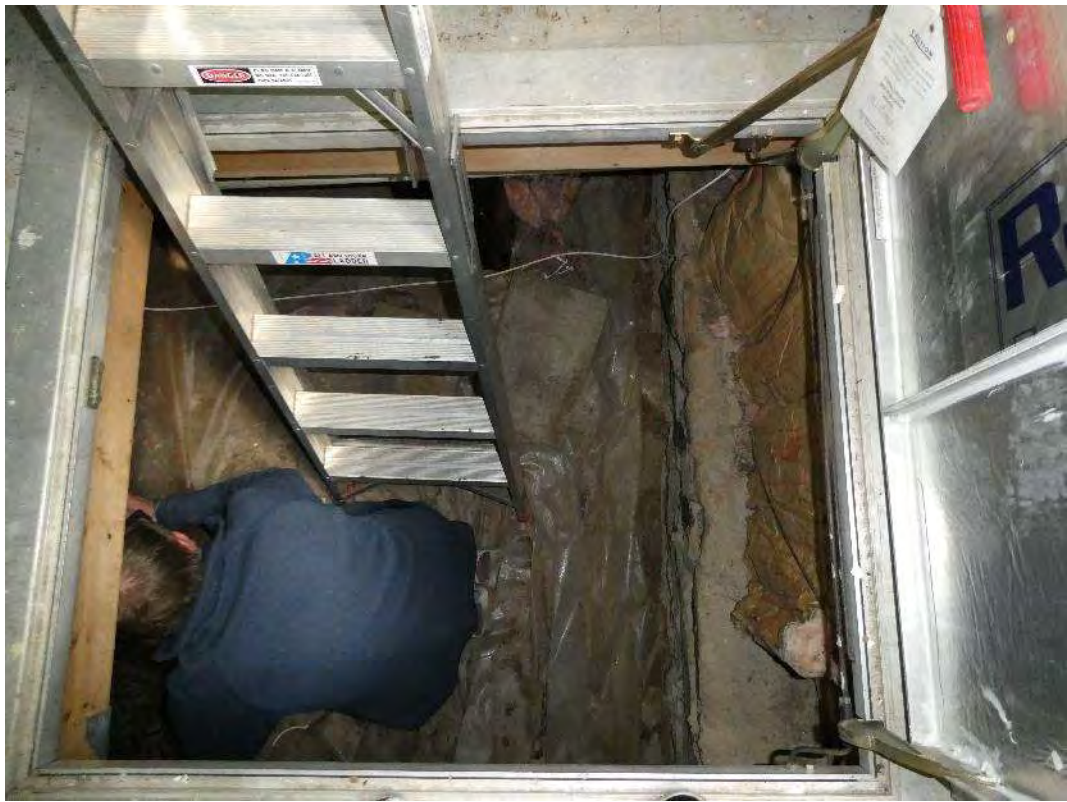
Photograph 9: Basement/crawlspace

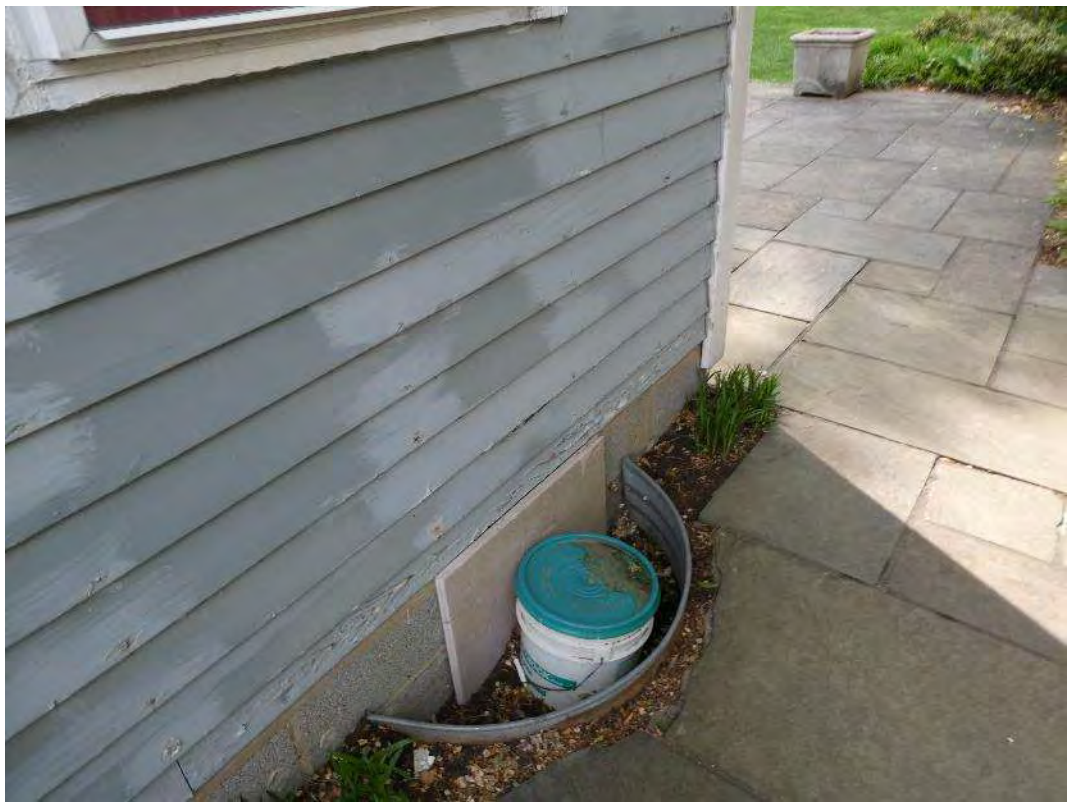
Photograph 10: Blocked sub-floor ventilation

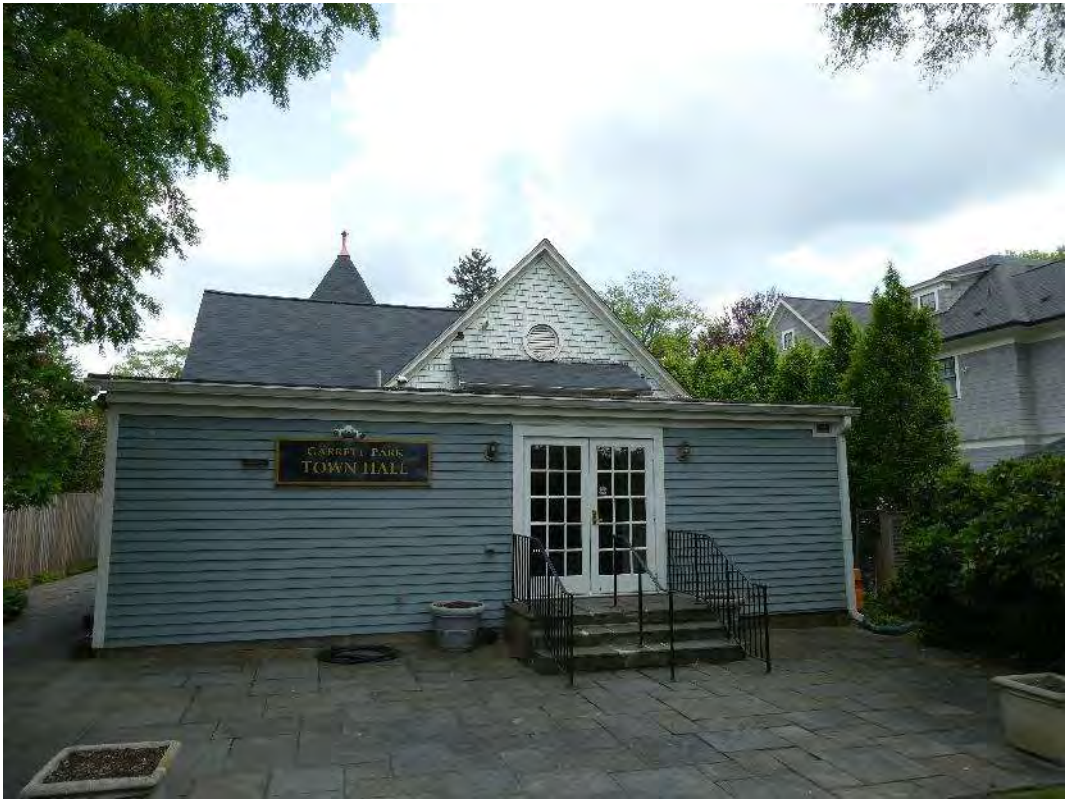
Photograph 11: Low slope and sloped roof systems viewed from rear yeard

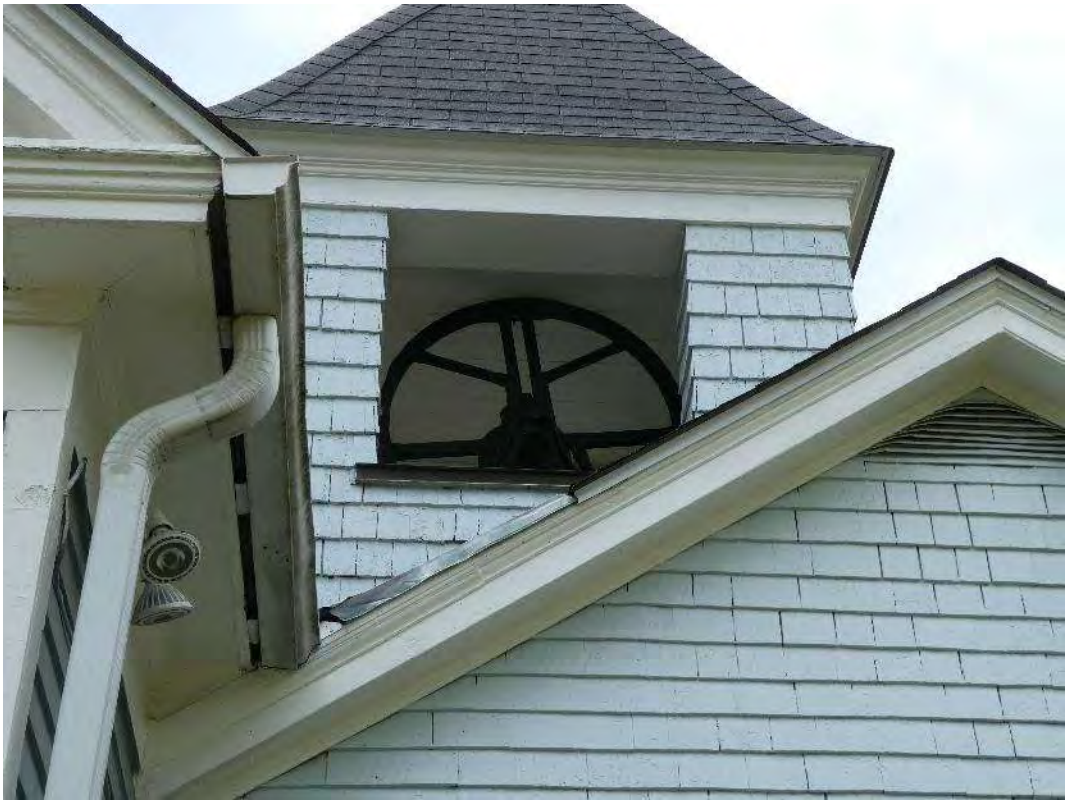
Photograph 12: Sloped roof systems and bell tower

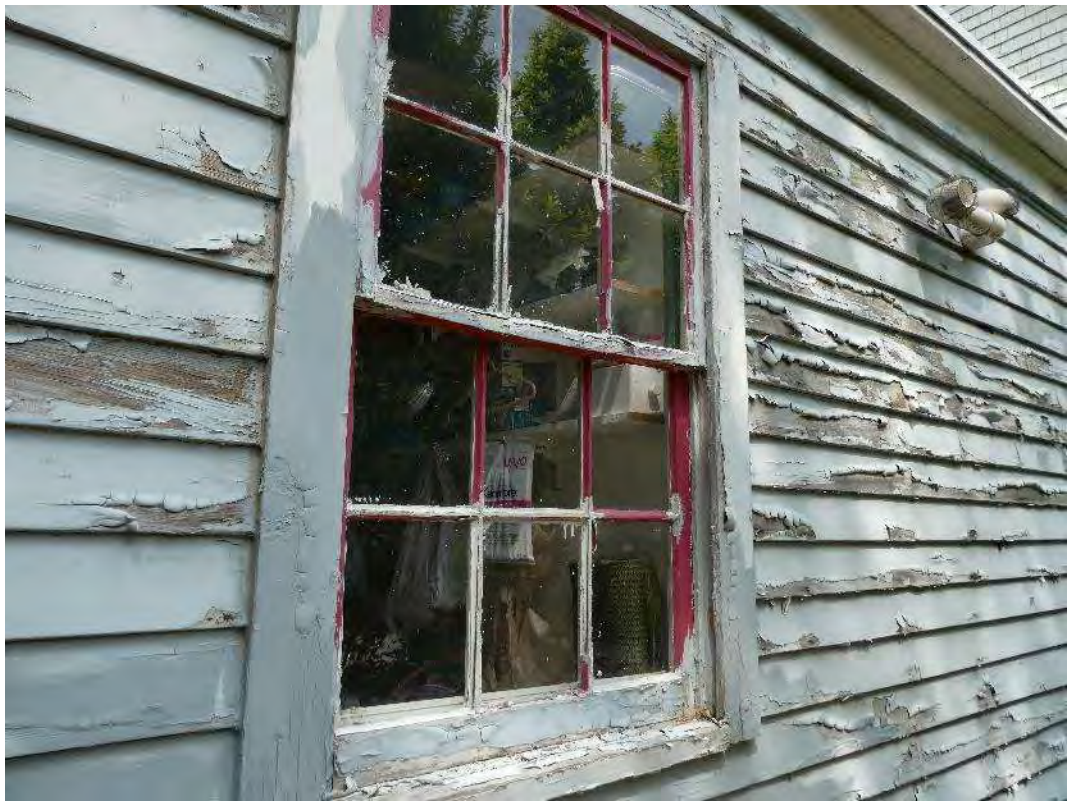
Photograph 13: Deteriorated paint and wood finishes to exterior

- Painting
 - Strip all existing exterior paint to bare wood and assume replacement of 50% of historic trim/ siding.
 - Strip paint on historic windows and restore the historic windows to fully operational condition.

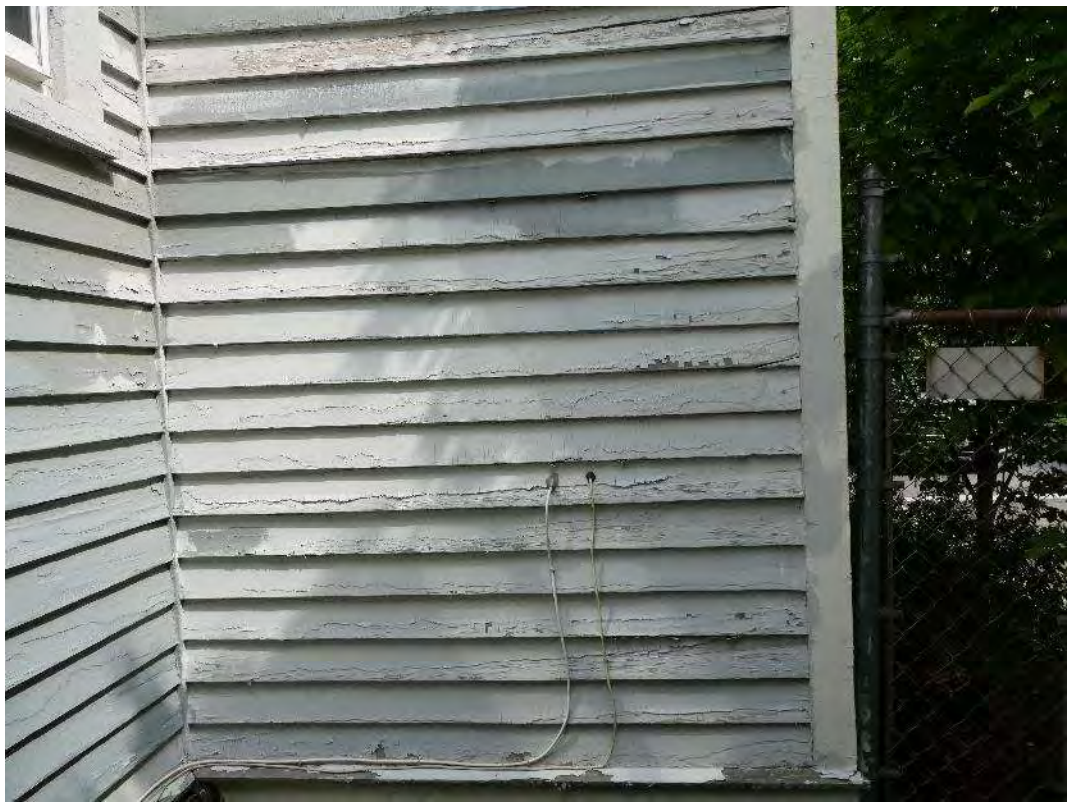
Photograph 14: Deteriorated wood siding

- Existing Exterior Walls and Trim: Repair 4-inch exposure cedar wood siding and trim; Scrape wood to bare wood
 - Assume 50% replacement of damaged wood siding and trim

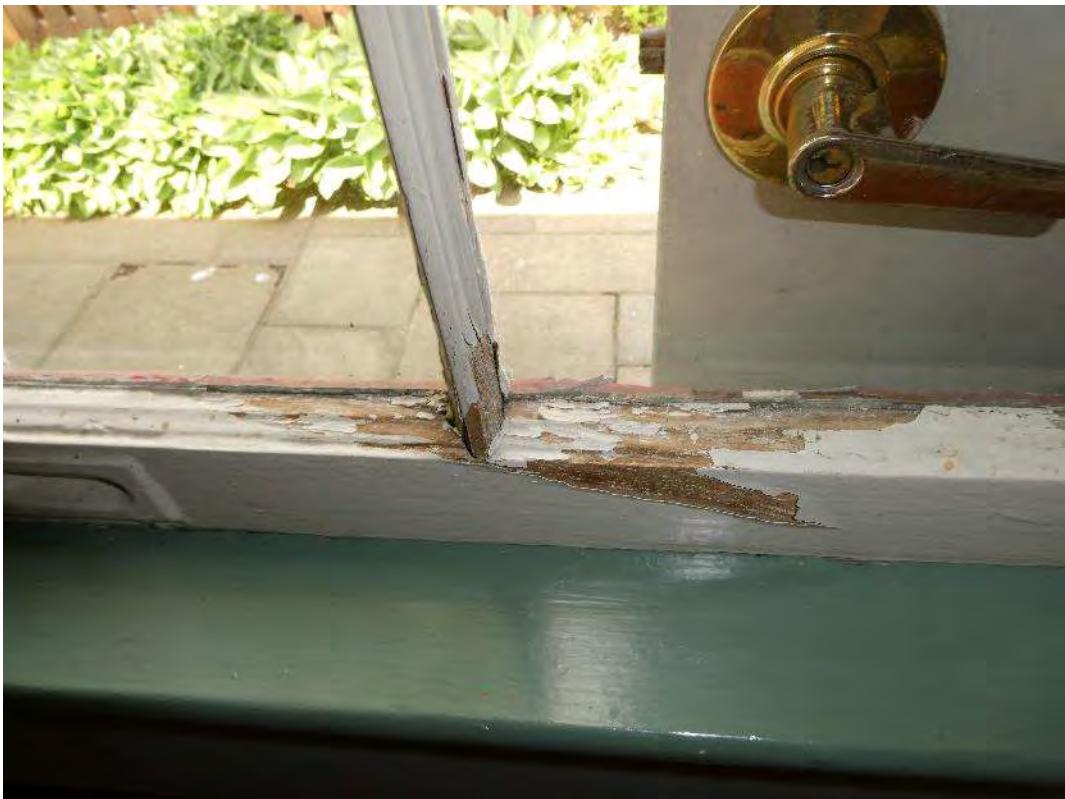
Photograph 15: Damaged windows, viewed from interior areas

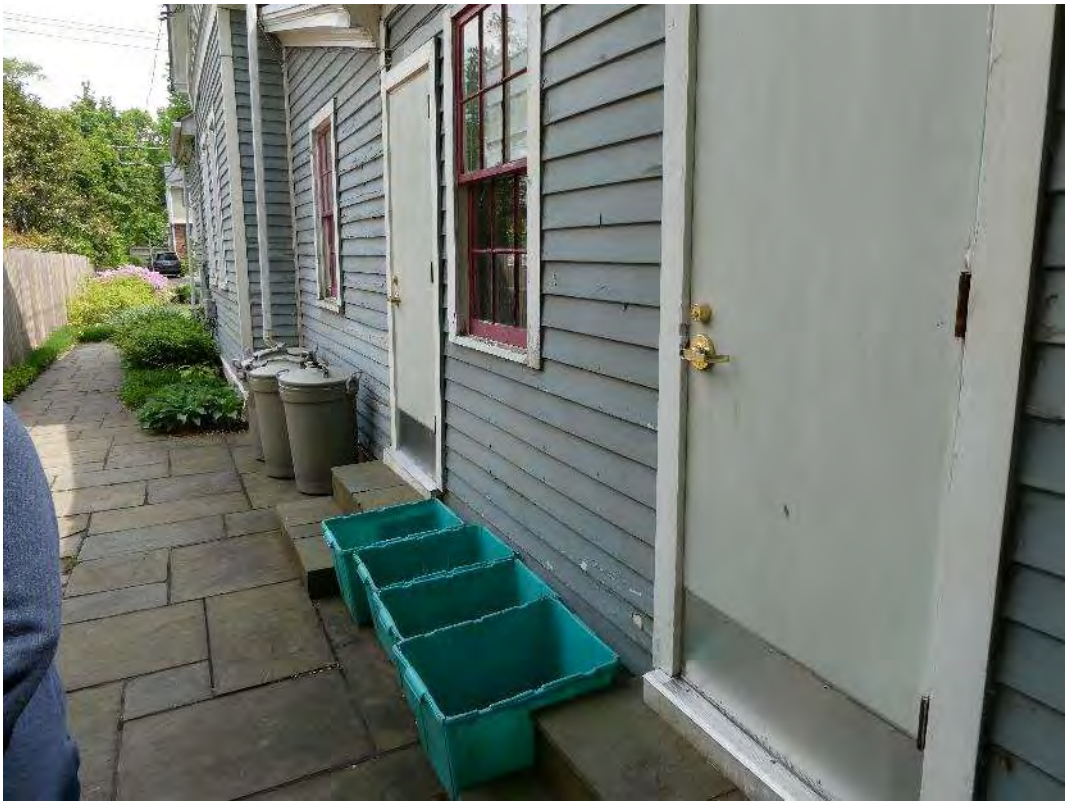
Photograph 16: Exterior doors, windows, and siding

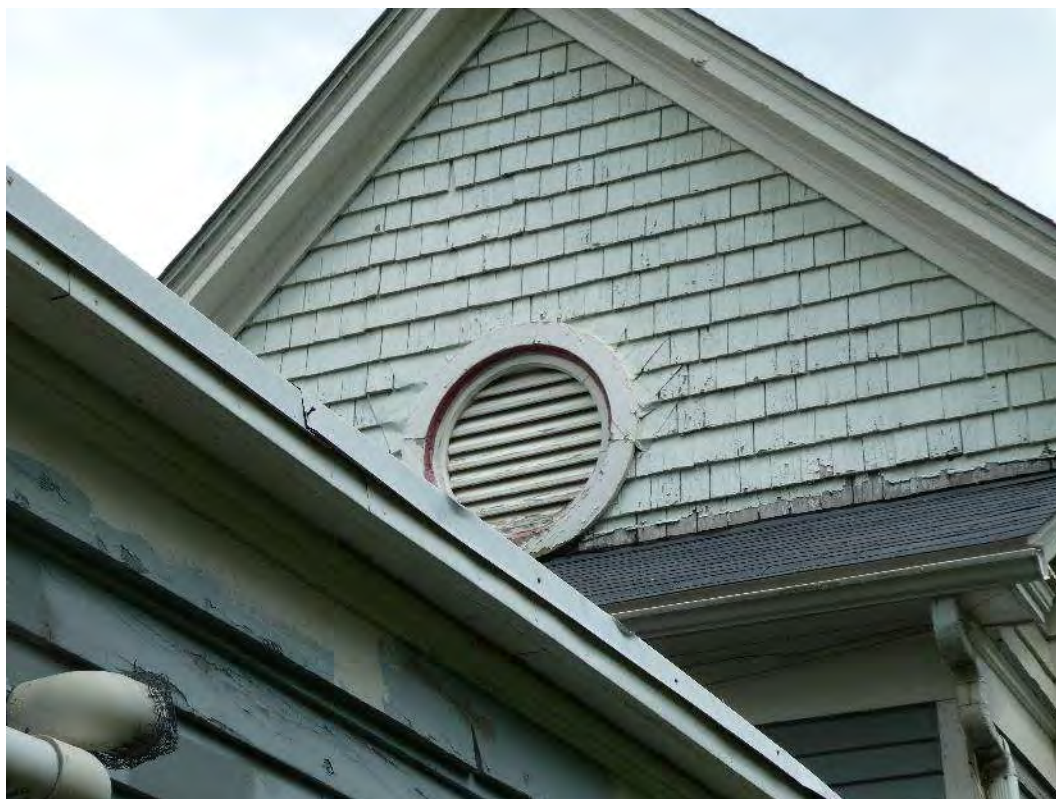
Photograph 17: Deteriorated wood shingles to wall at apex

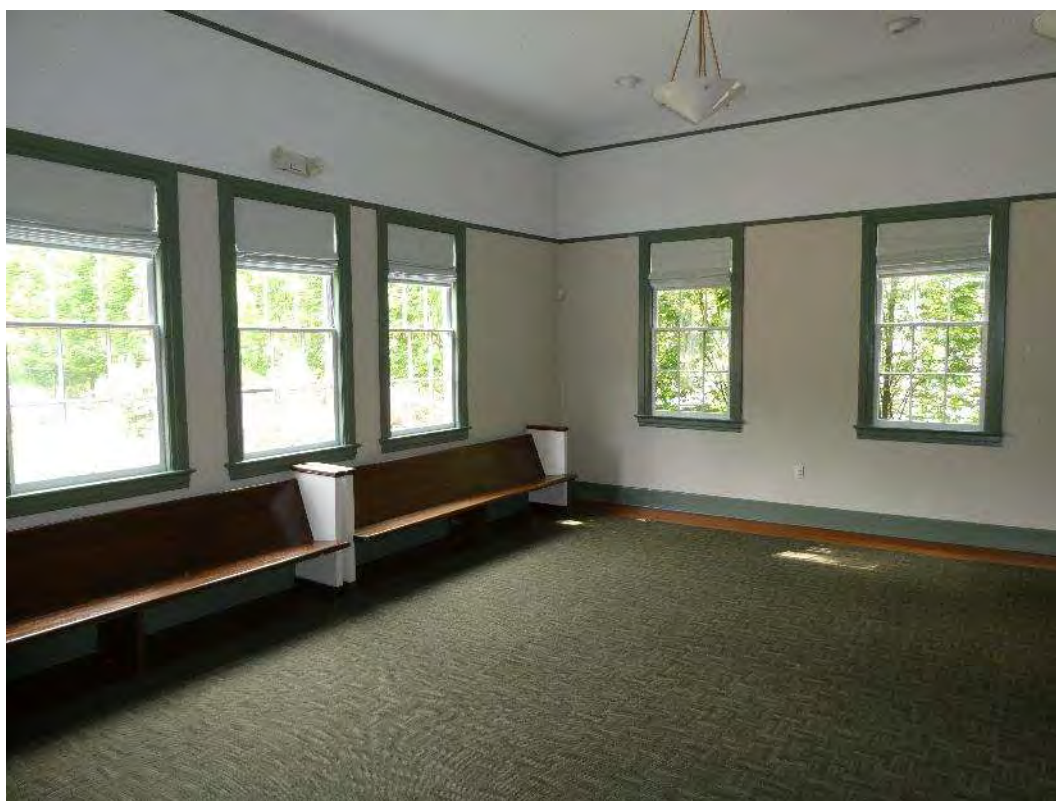
Photograph 18: Interior finishes to Main Hall

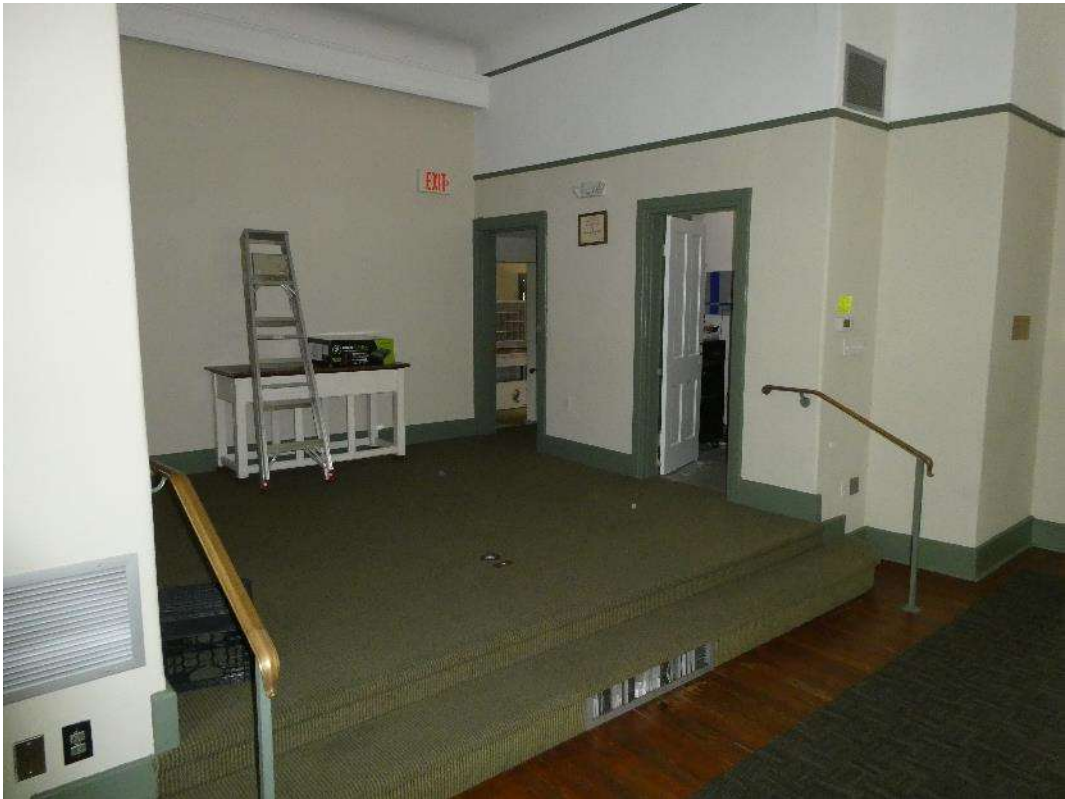
Photograph 19: Finishes to Stage area

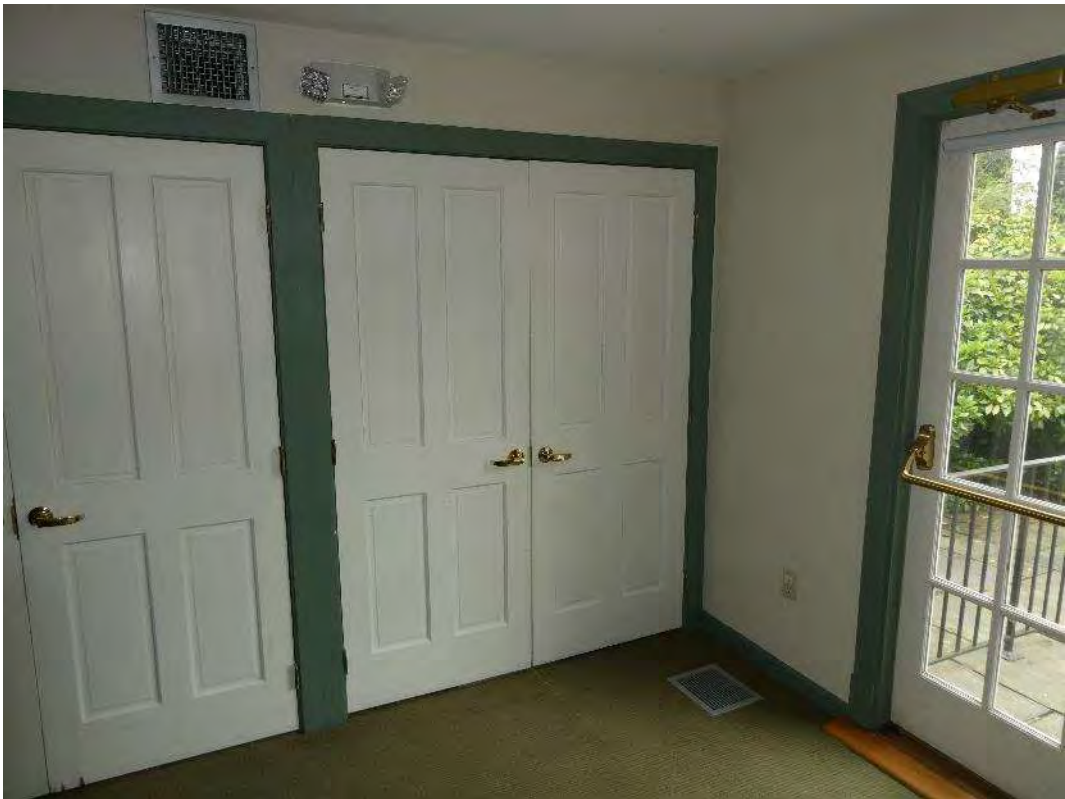
Photograph 20: Finishes at rear Lounge area

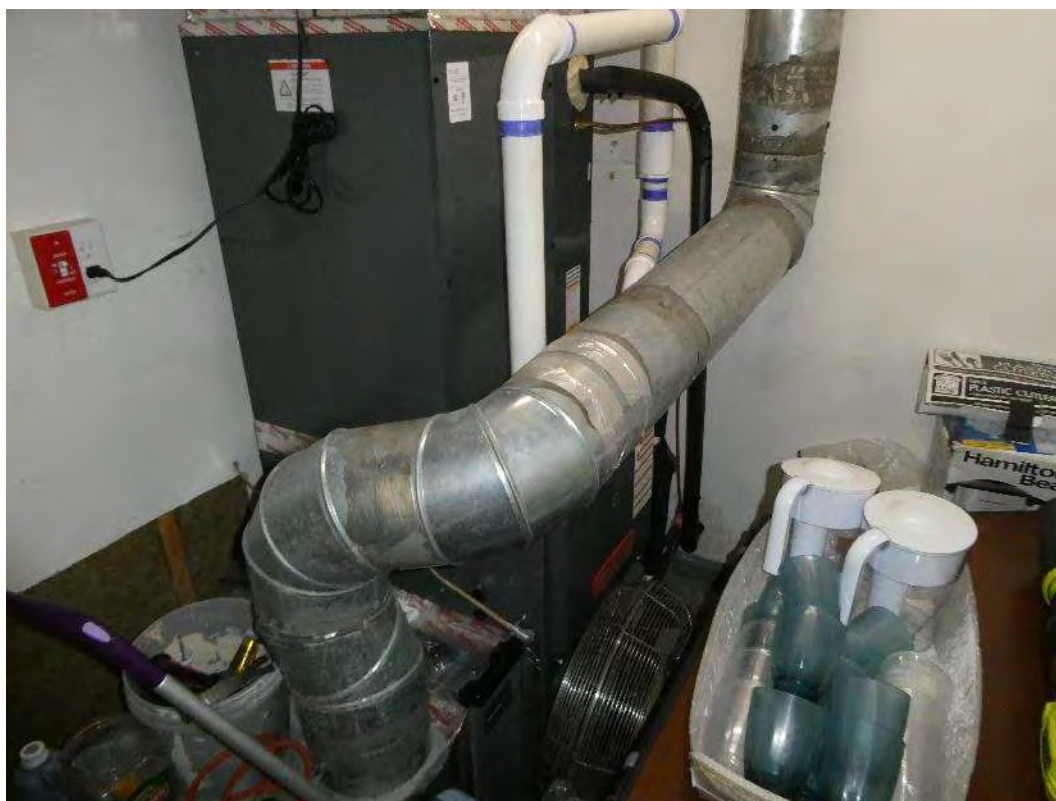
Photograph 21: Gas furnace in closet area serving rear of building

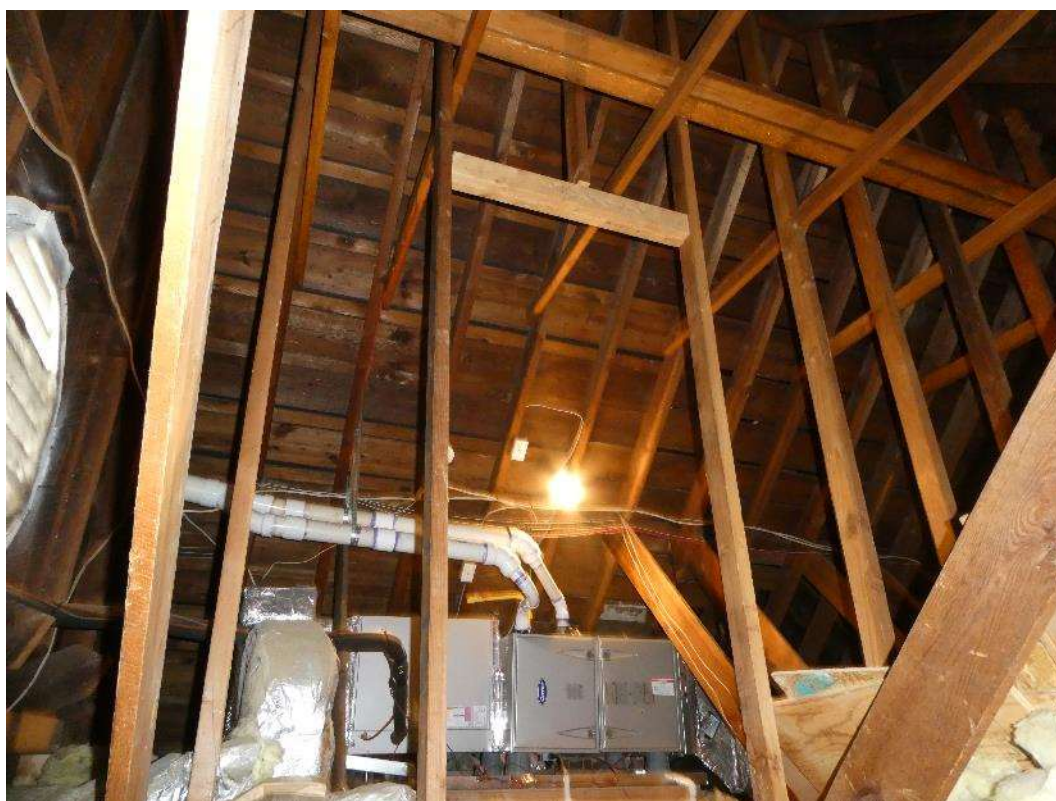
Photograph 22: Gas furnace in attic serving front of building

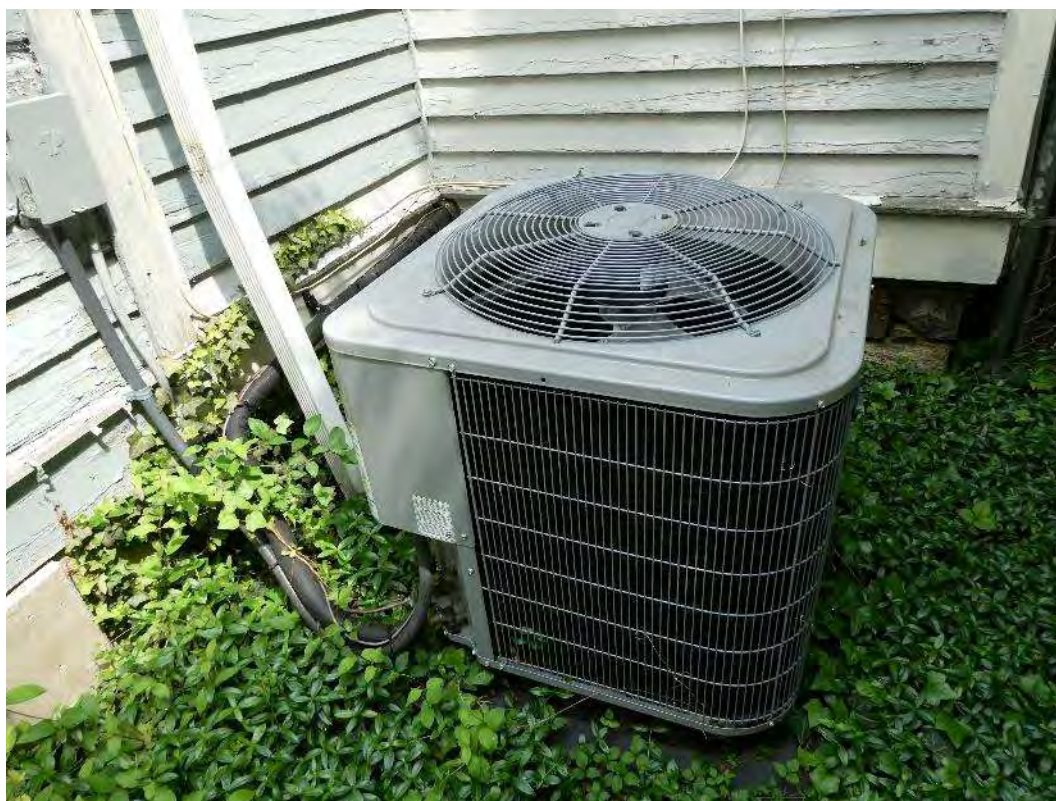
Photograph 23: Exterior condensing unit

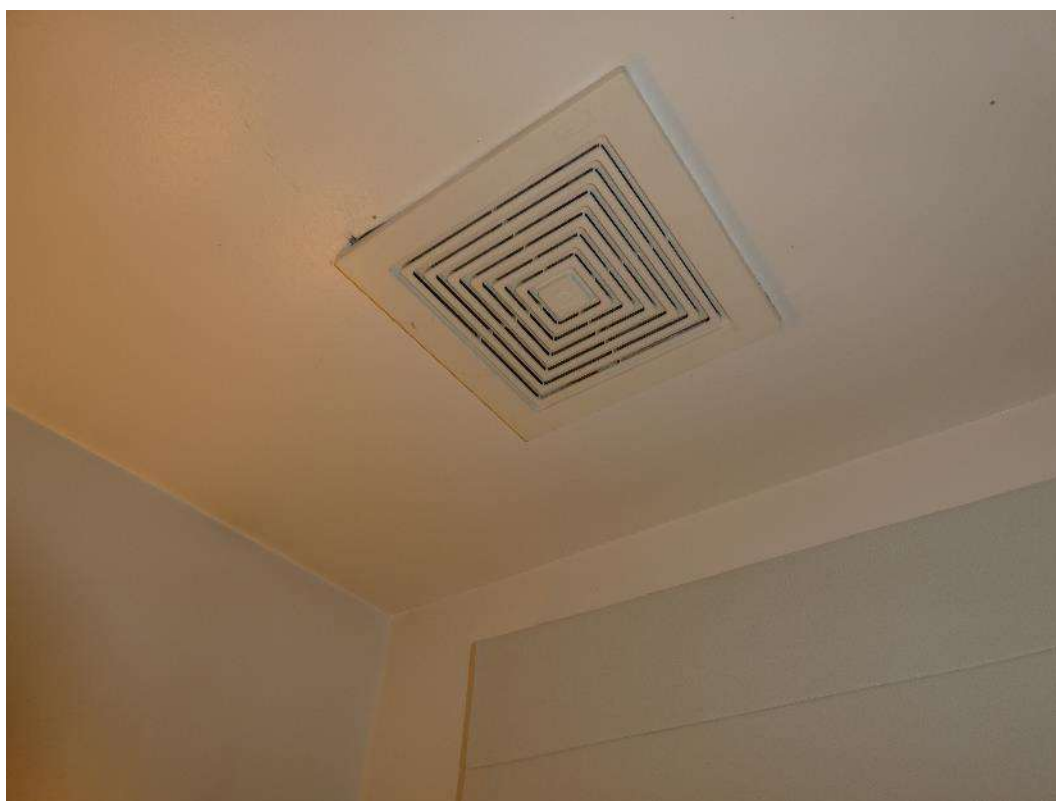
Photograph 24: Exhaust fan in restroom

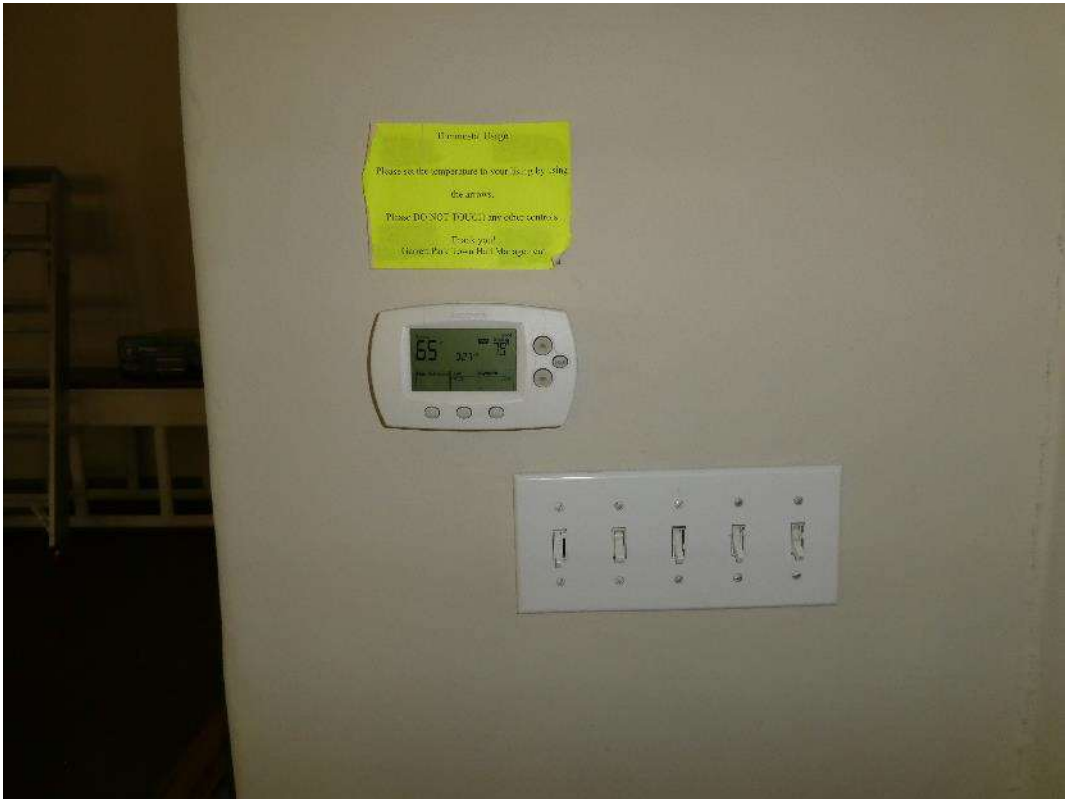
Photograph 25: Heating and cooling controls

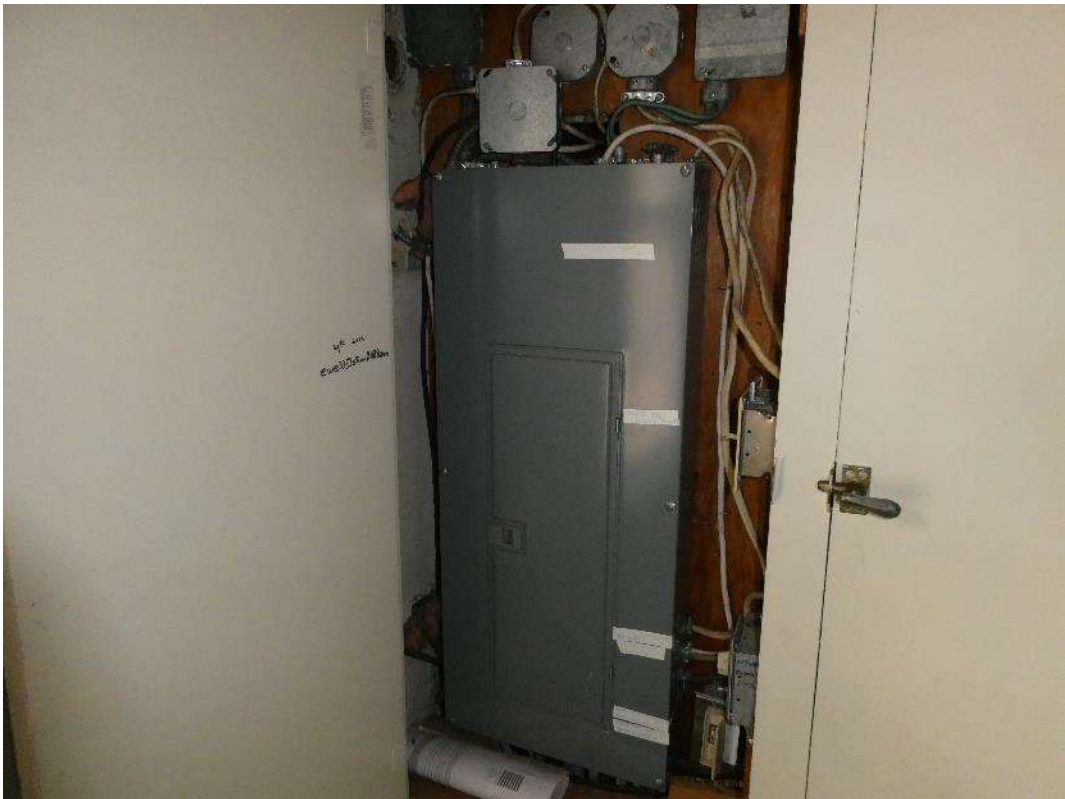
Photograph 26: Electrical panelboard serving building
