Town of Garrett Park

To: Mayor and Town Council
From: Barbara B. Matthews, Town Manager
Subject: Town Hall Renovation
Date: November 12, 2024

Property Condition Review

Garrett Park Town Hall

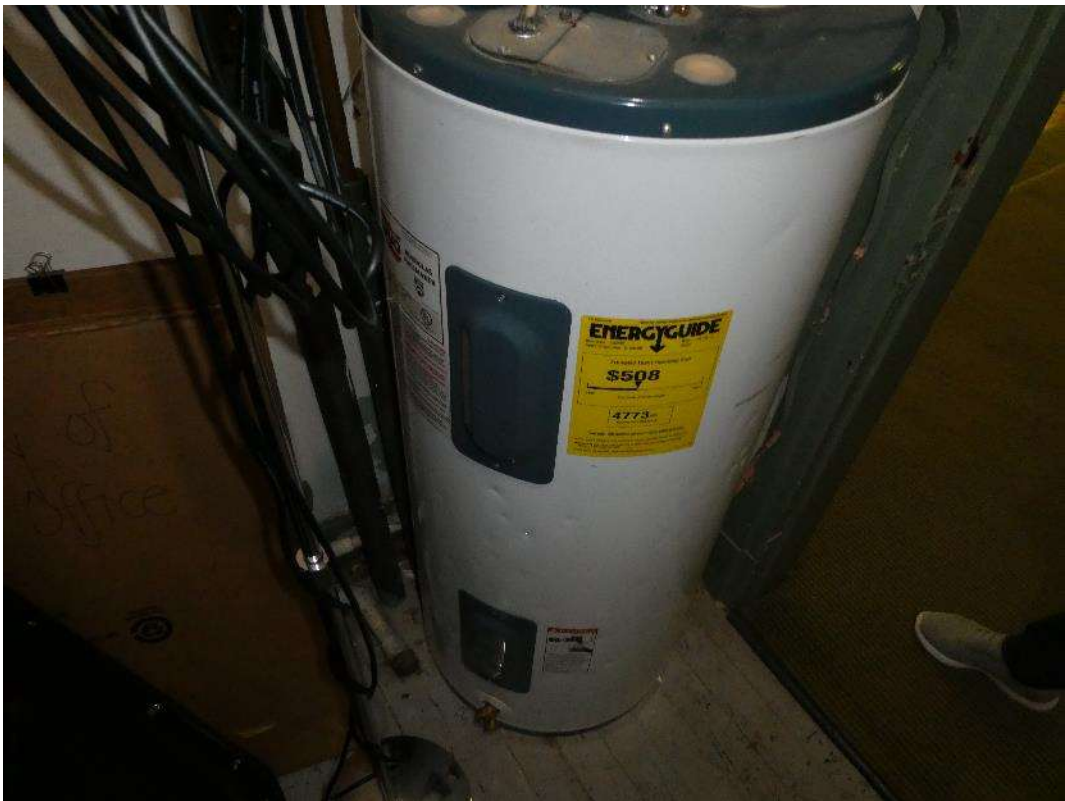
Photograph 29: Electric domestic water heater

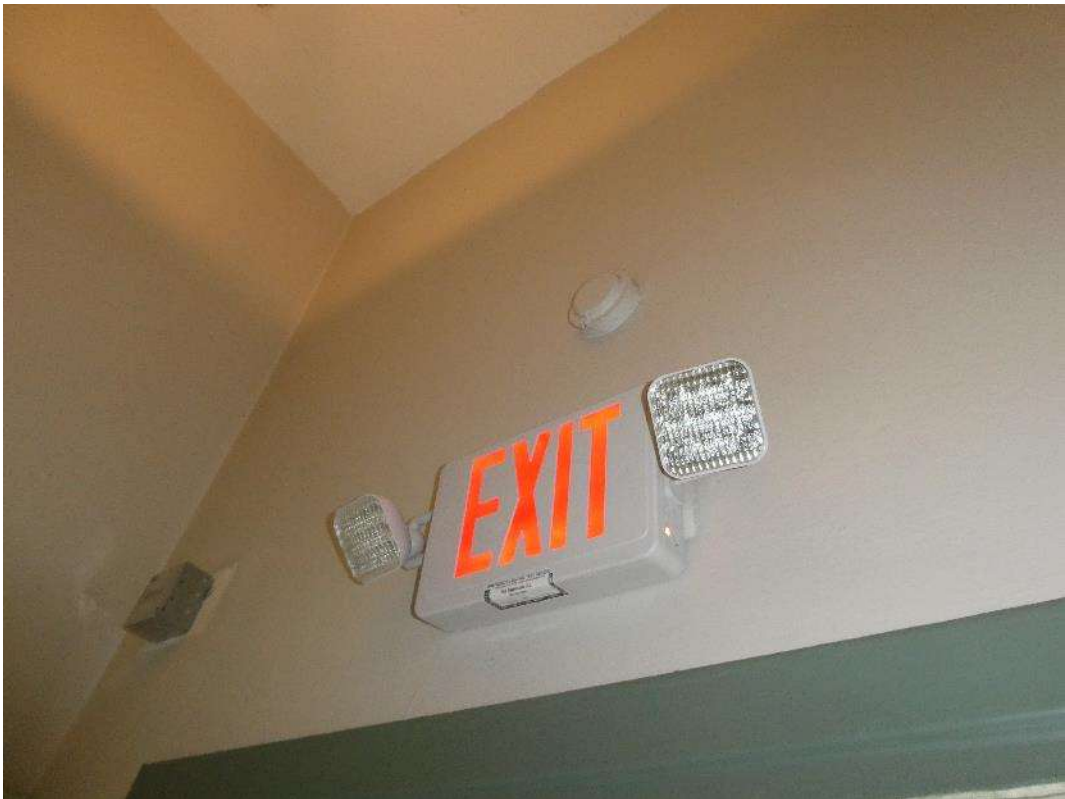
Photograph 30: Fire exit signage and egress lighting

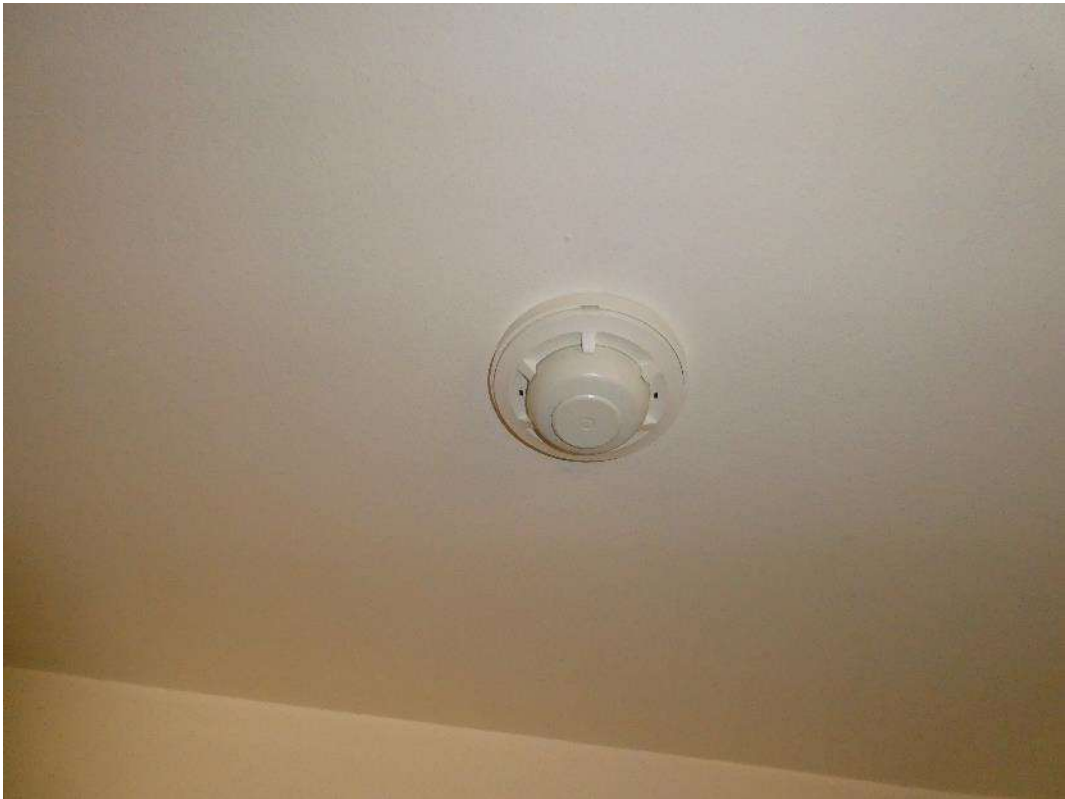
Photograph 31: Smoke detector

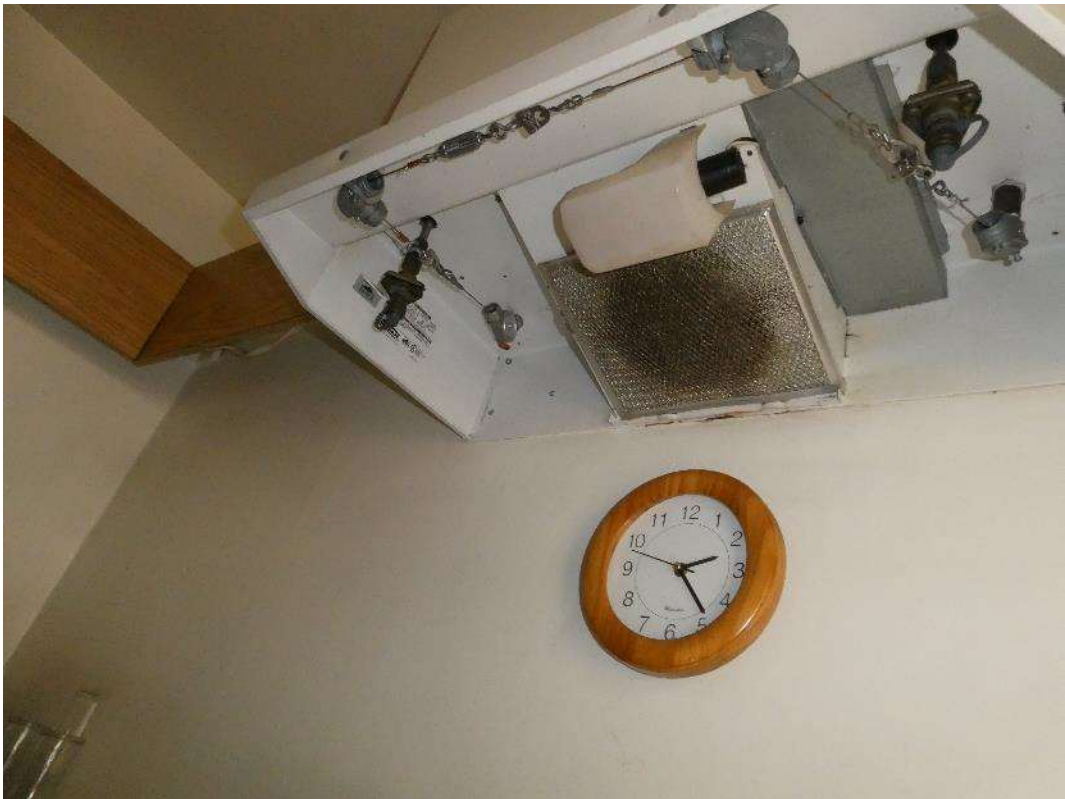
Photograph 32: Chemical suppression system above range hood

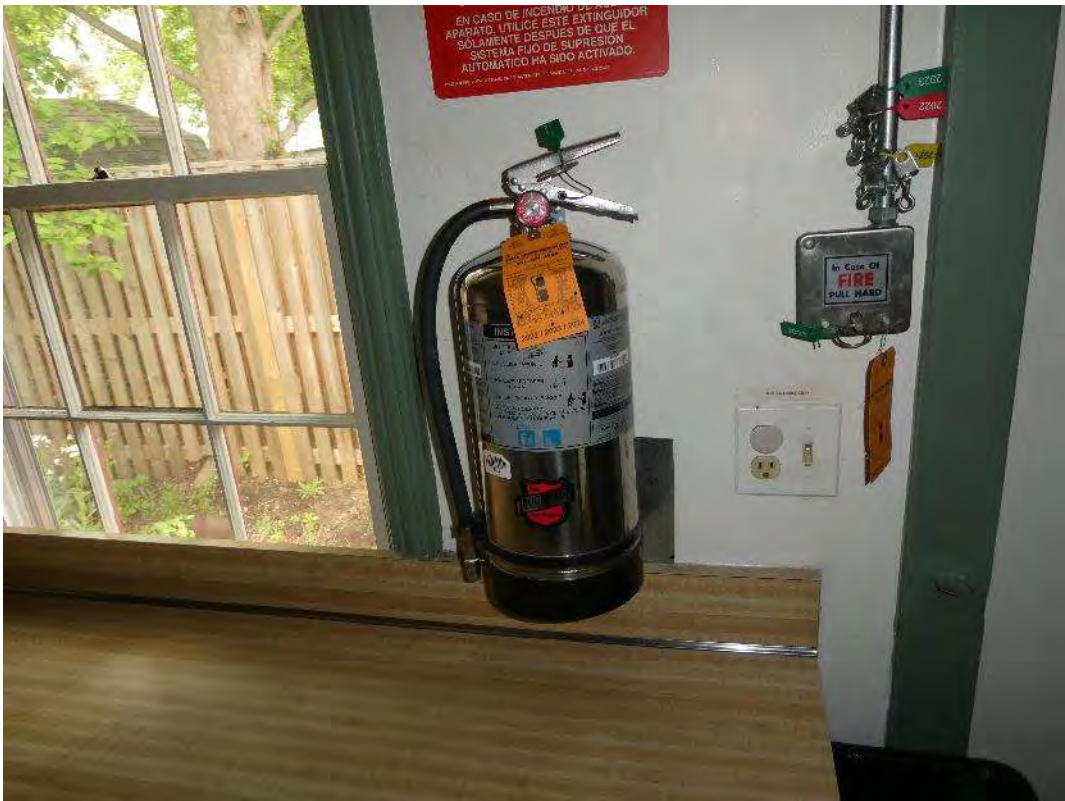
Photograph 33: Handheld fire extinguisher
