Michigan DNR Trails Inventory on Beaver Island Summer of 2016 Report

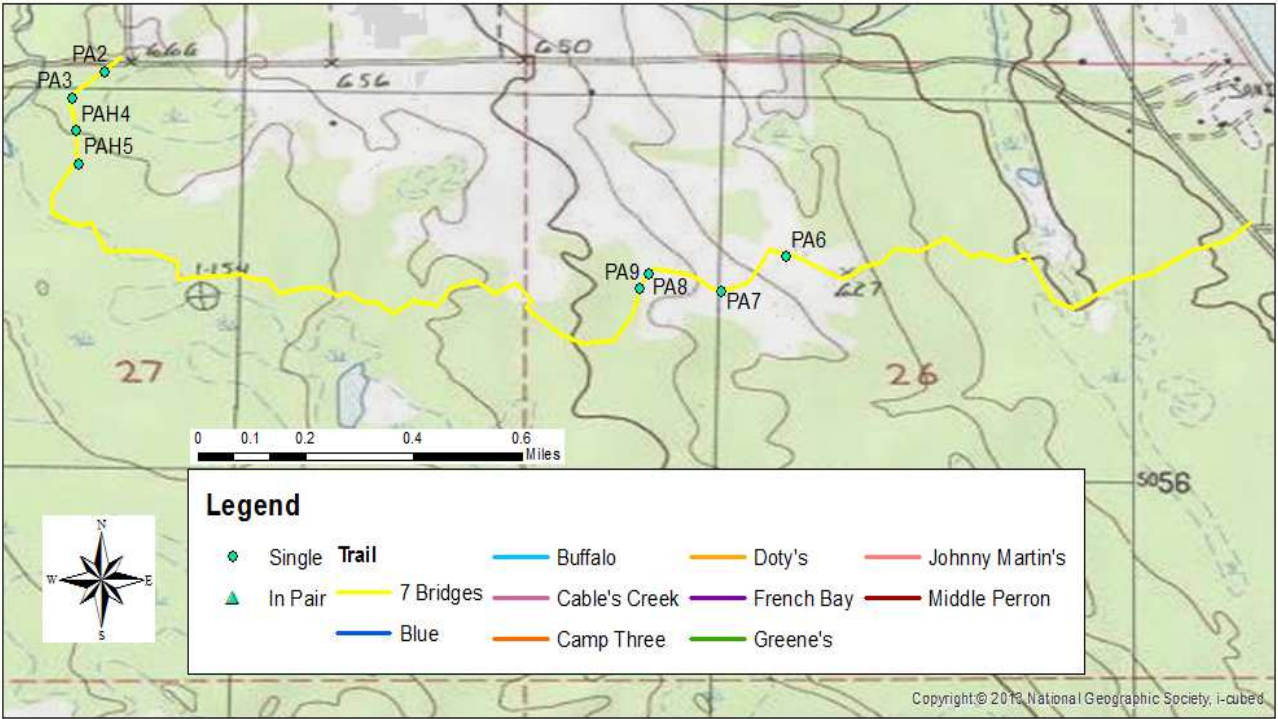
Figure 4: Problem areas along the Seven Bridges Trail

Starting from the end closest to the Bill Wagner Campground, the Seven Bridges Trail has few issues (Figure 4). There are some posts that are missing the small eagle markers, but the trail is easy to follow. PA6 is a stand of woody young plants that blocks the trail; however, someone has since cleared a path around this stand to continue on the trail. Similar clearing once a year may help keep the stand from taking over this part of the trail. At the opposite end, the start of the trail is very swampy and easy to lose. This swampy portion stretches between PA3 and PAH4, and may be fixed through a series of slightly raised foot bridges or boardwalks. Note: PAH5 was a group of leaning trees that has since been removed. Orange paint was used to mark areas where the trail was easily lost and to delineate a section of trail that was created prior to this project (Figure 5).

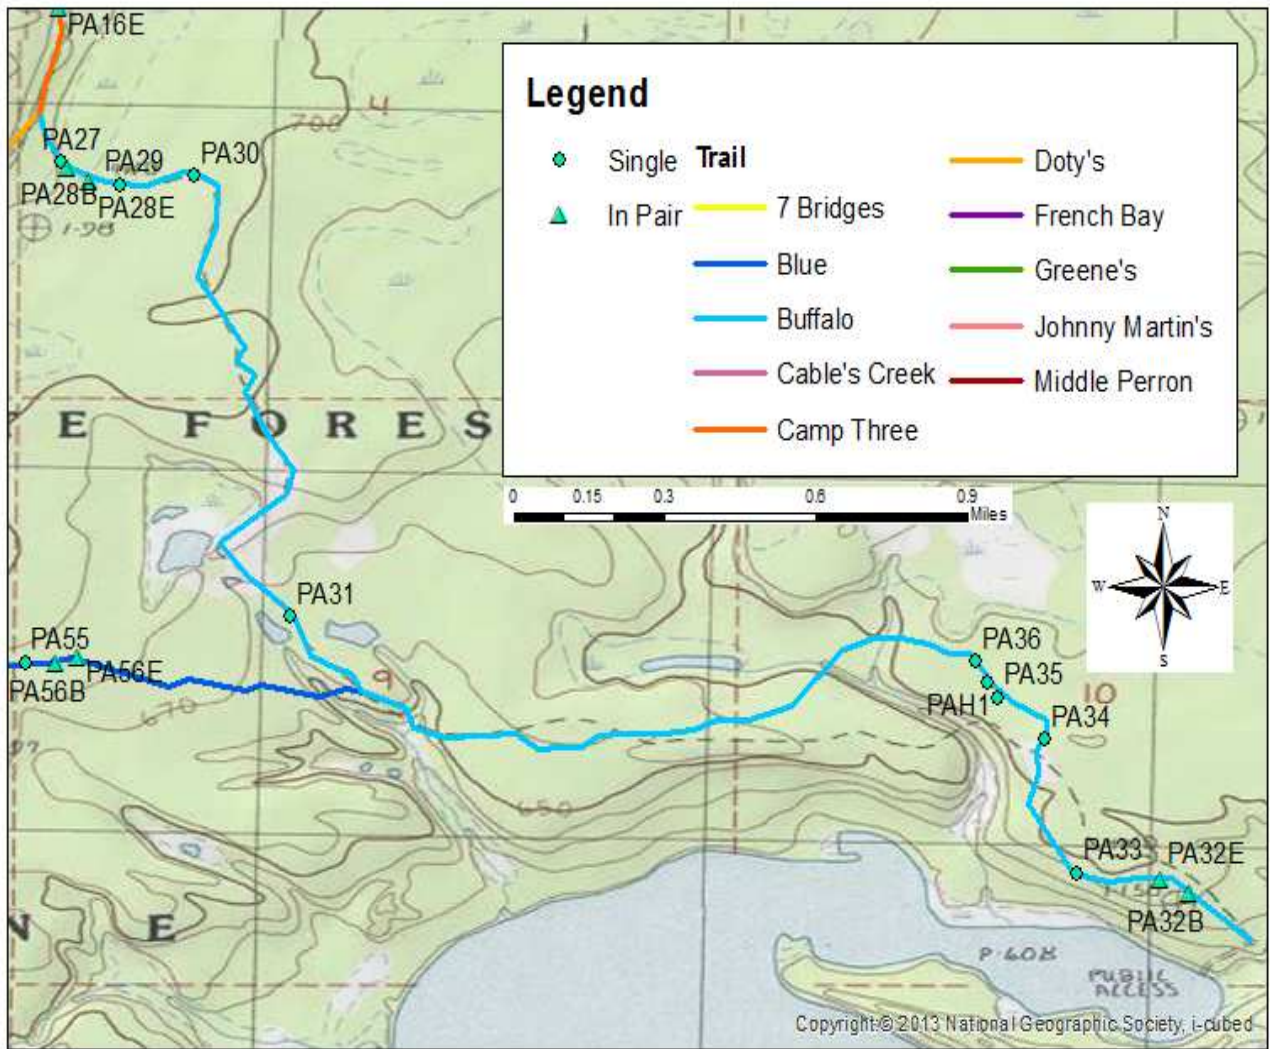
Figure 6: Problem areas along Buffalo's Camp trail

Buffalo's Camp Trail, starting at Lake Geneserath, has mild ruts and a few muddy areas (Figure 6). A very large tree that had been blocking the main trail was removed, though a path had been cleared as a work around large enough for vehicles to one side. Much of the trail after the

second culvert is clear of ruts and lacks problem areas. This trail also has a dense area of raspberry and blackberry bushes that could be trimmed periodically to keep them from growing into the trail. After the bridge, the trail does not get bad again until it passes through a swampy area with a stream and very tall grasses. Buffalo's Camp Trail is quite muddy at the north end connecting with Doty's Trail and Camp Three Trail, and someone attempted to fix a few of these areas by cutting down small trees and laying them across the trail making it difficult for hikers to walk over.

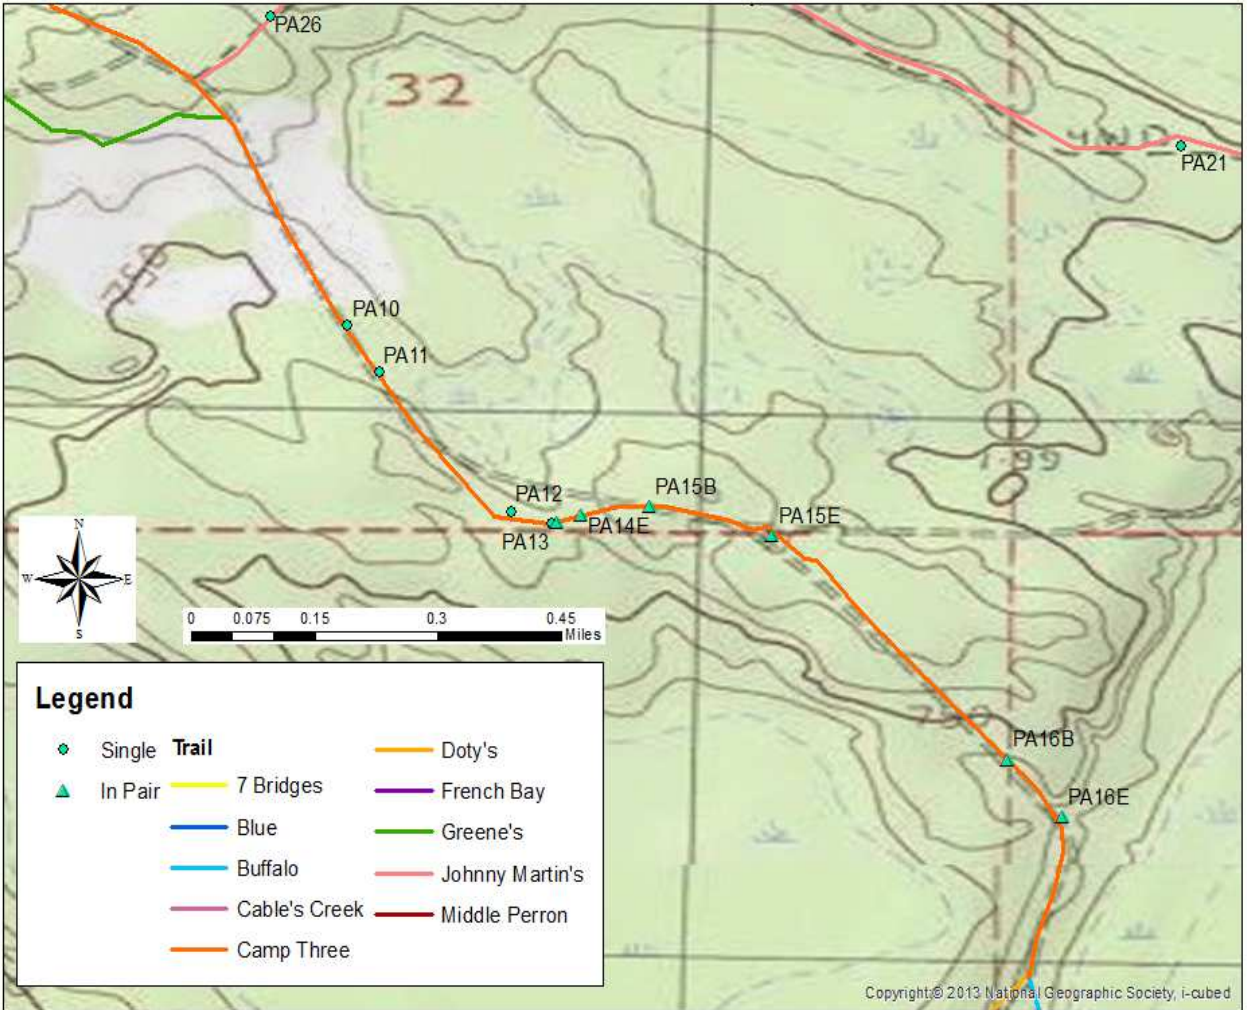
Figure 7: Problem areas along Camp Three trail

The Camp Three Trail begins as a gravel road and is passable with a vehicle for most of its length. After the intersection with the Johnny Martin's Trail and Greene's Lake Trail, however, it has a series of large and muddy permanent puddles (Figure 7). Many of these are deeper than one would expect, or have soft mud bottoms. PA16, marked with PA16B and PA16E, is a long, muddy rut running down a slight hill, and makes the trail impassable from the south.

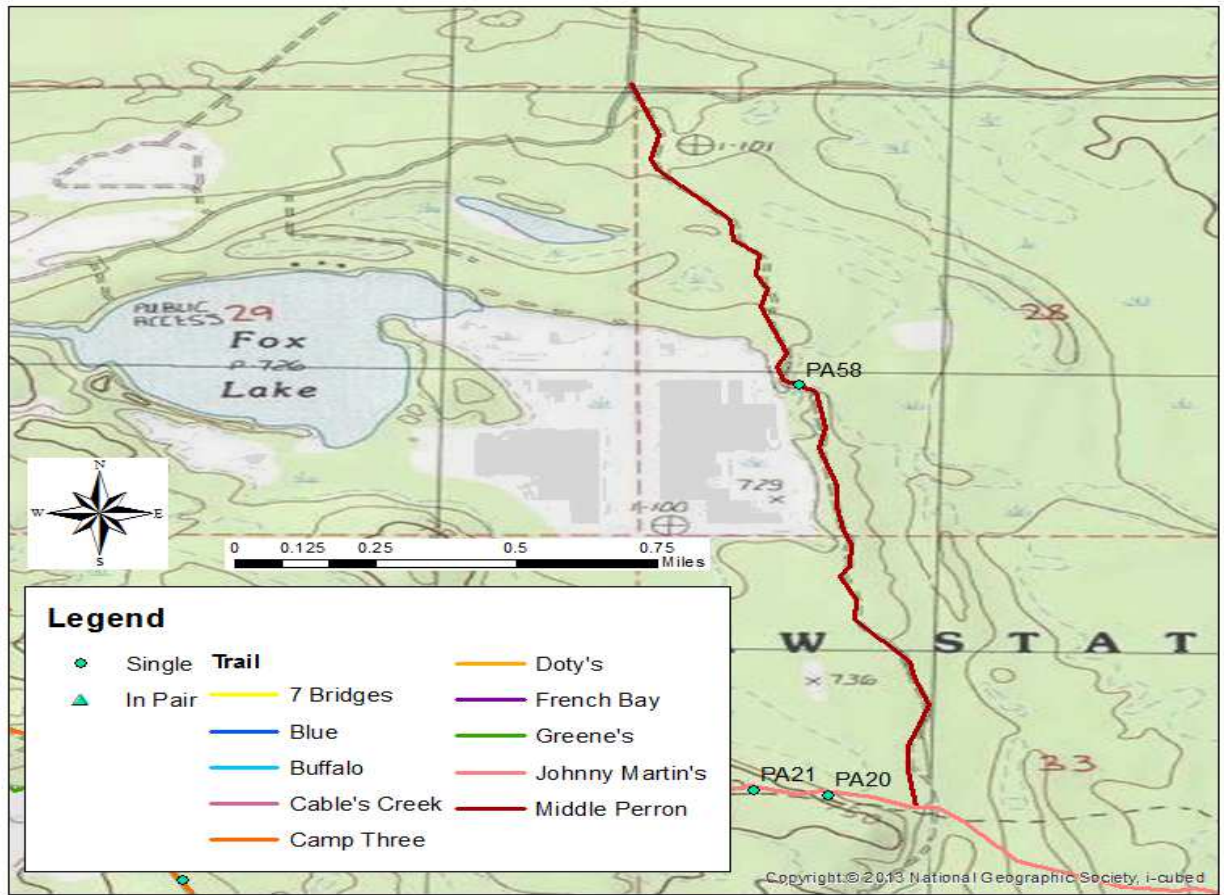
Figure 8: Problem areas along Middle Perron's trail

The Middle Perron's Trail is completely passable by maintenance vehicle and has few problem areas (Figure 8). There are a couple of large and permanent puddles along its length. After a period of heavy rain, they may become difficult to hike around. The largest and perhaps easiest of these to fix is PA58.

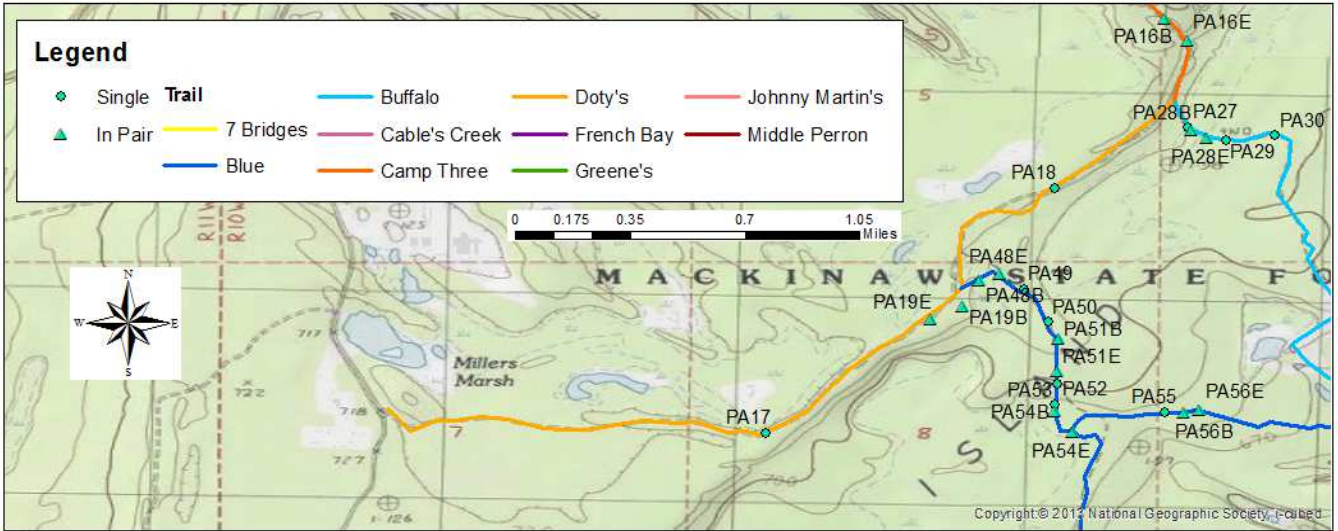
Figure 9: Problem areas along Doty's trail

Doty's Trail is also passable with a maintenance vehicle. The problem areas are large and permanent puddles, but these do not stop a vehicle and can be hiked around when the water is low. The largest area of concern is a long stretch of trail right before the intersection with Blue Trail, marked by PA19B and PA19E, which has deep ruts (Figure 9). This section is around 500 ft. long, but does not necessarily impede vehicles.

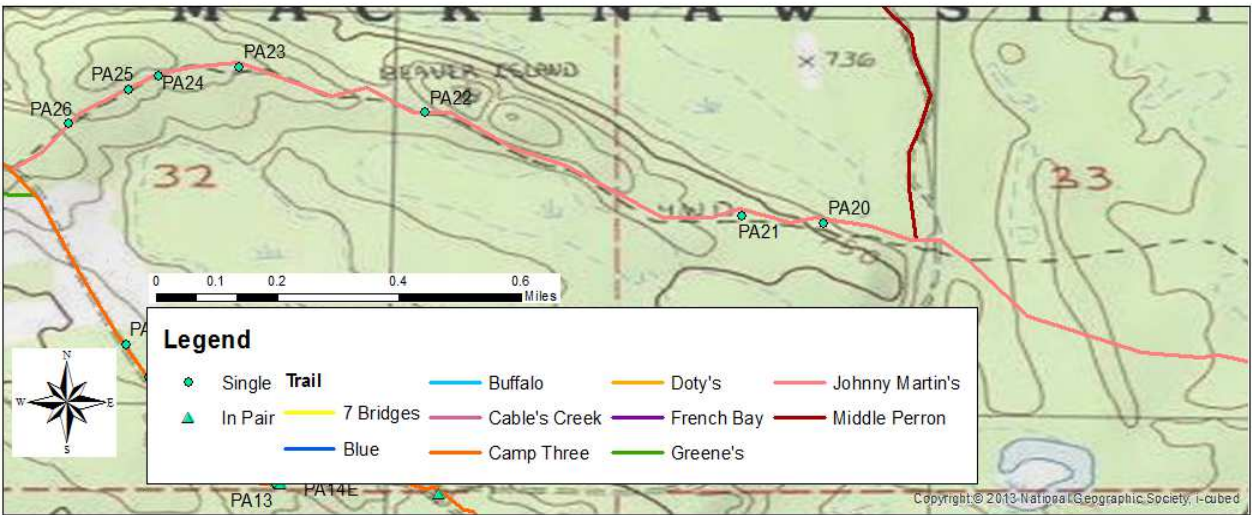
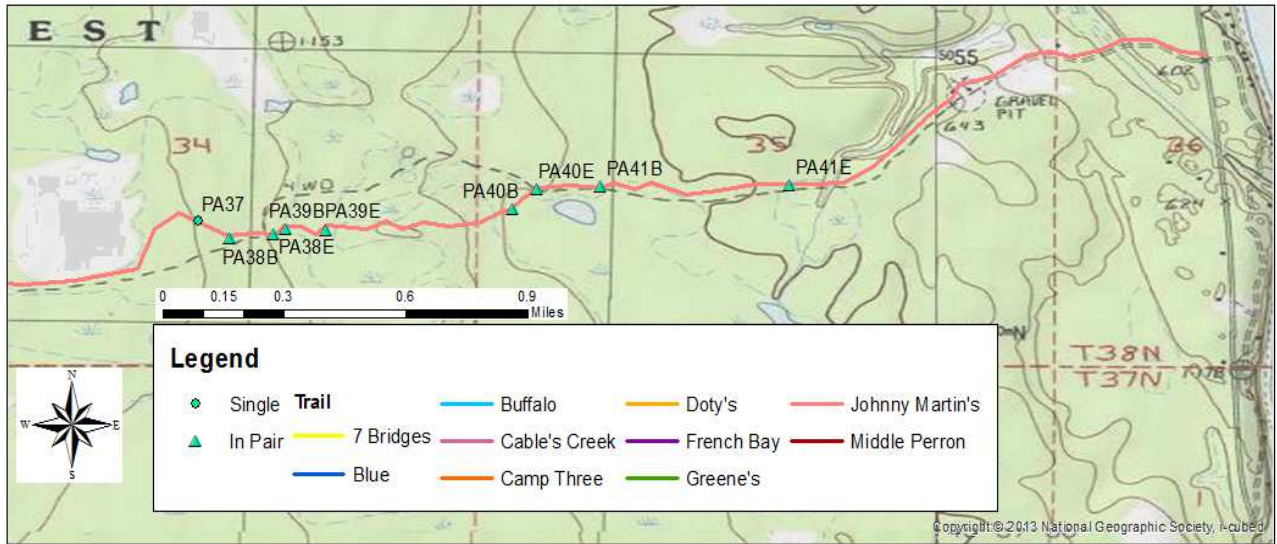
Beginning from the west, Johnny Martin's Trail has a series of puddles that do not impede driving, but may be difficult to hike around (Figures 10 and 11). The worst of these is PA21, as it has been widened by frequent use and an alternative workaround that has also become part of the problem. A large section of this trail after the intersection with Middle Perron's Trail is in good condition. Here, the only problems encountered were overgrown berry bushes and branches reaching into the trail, which were trimmed back. Around PA37, the trail is largely unable to be driven due to soft muddy ruts and soon after narrows to passage by foot traffic only. This area is marked as PA38B and PA38E as it runs through an open wet area with standing water. Logs have been placed in many areas to help hikers pass these areas, but a small foot bridge may provide a better fix. After this, the trail widens more and returns to woodlands again. Another issue is not encountered until PA40B and PA40E. After this point, the trail is largely overgrown with tall grasses and young woody shrubs, and has many deep wet sections. This was the muddiest hike of all of the trails, however, it is important to note that on a later date, the trail had largely dried up and was easy to hike through, with only the tall thick areas of grasses causing any issue. After the culvert, the trail then has very few issues and eventually turns into Johnny Martin's Trail, which is not portrayed well on the map used for reference. Much of this trail was overgrown with grasses, and would benefit from periodic clearing or more foot traffic to keep the plants at bay. Many of the colored marks on the trees

had been covered with gray spray paint just west of the culvert. The main trail is now marked with red spray paint from the intersection with Middle Perron's Trail to the culvert.

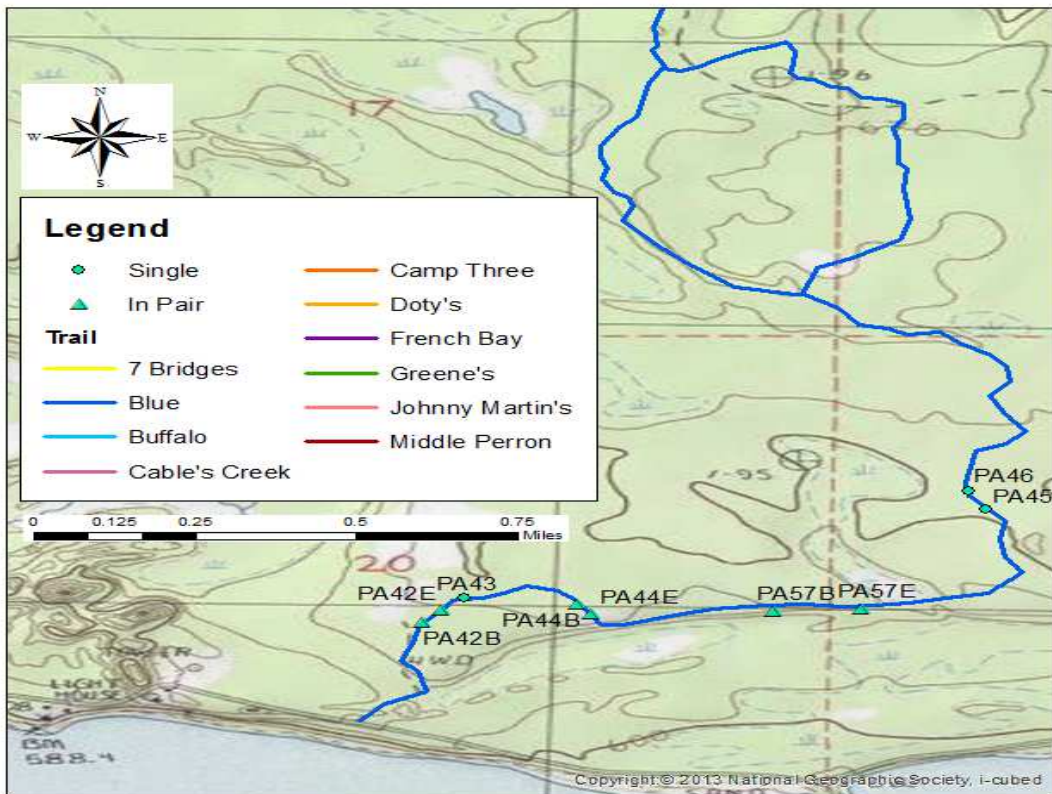
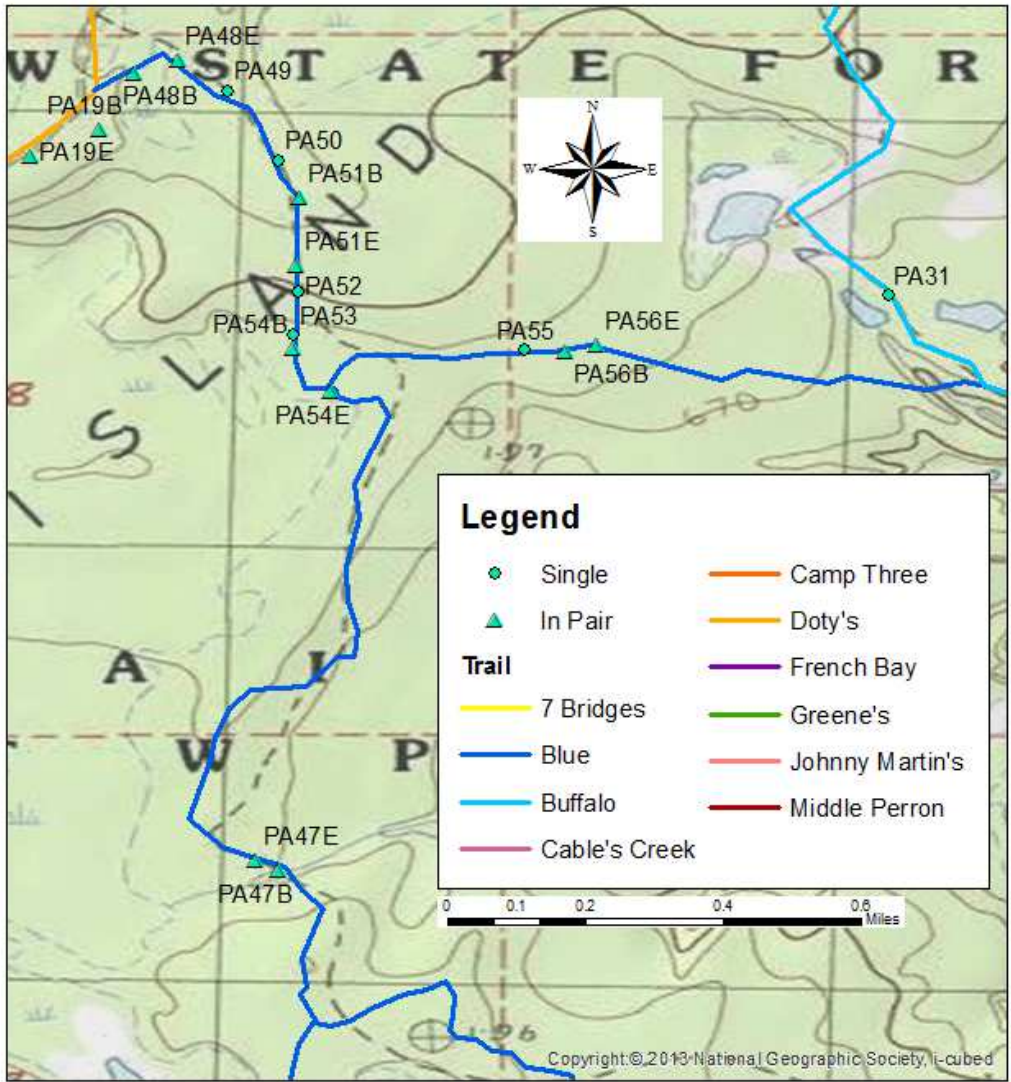
The Blue Trail begins as a small gravel road that leads to a small parking area. Many of the problem areas near the beginning of this trail are deep ruts, with mild stretches of ruts in between (Figures 12 and 13). After the last of these ruts, the trail is in good condition until further on. There are many side trails branching off the Blue Trail, and maps used for reference were inconsistent. There is a Y intersection on this trail that leads to a number of different footpaths. Some of these side trails may make it difficult to stay on the main path.

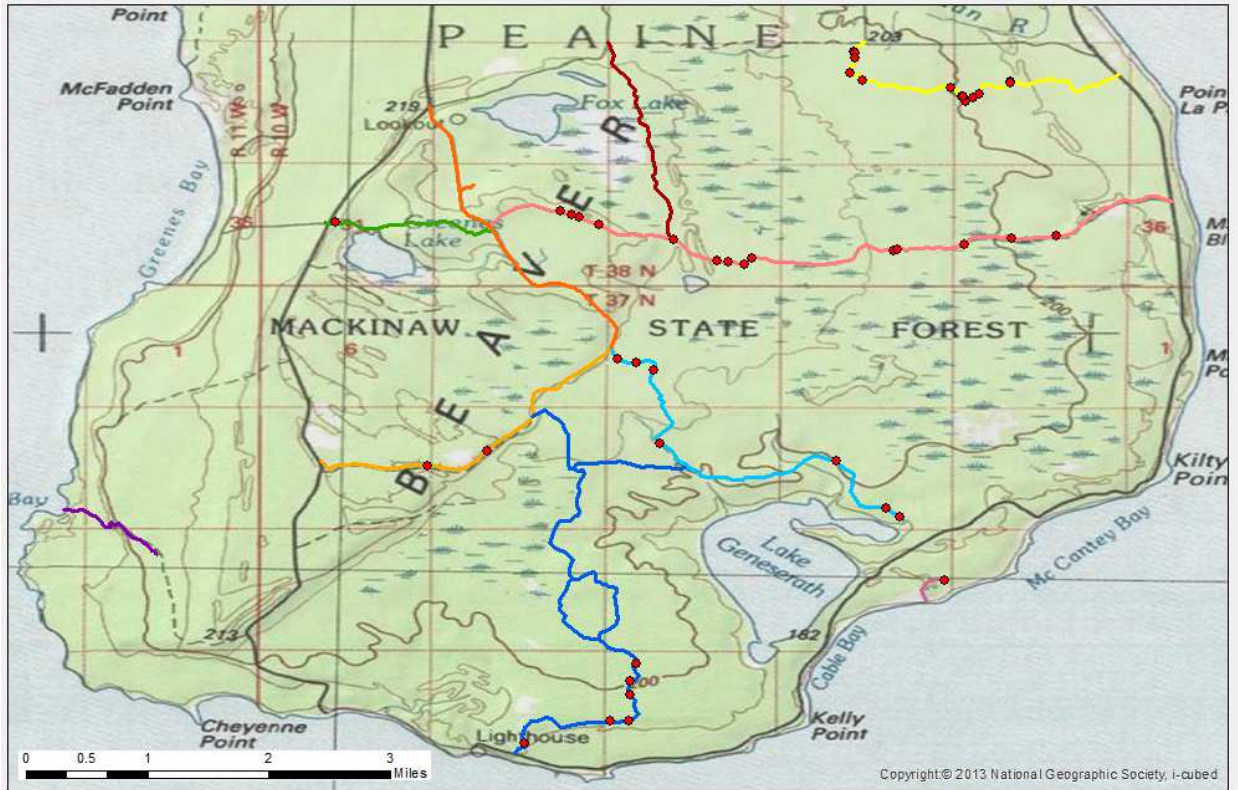
Figure 14. Invasive species occurrences along trails

Aside from spotted knapweed, the only other invasive species that we encountered on the trails was European swamp thistle (EST). EST was found to be prevalent on many of the trails throughout the island (Figure 14). Some trails only had a few small groupings of plants, while others had large pockets and individual plants throughout the entire length of the trail. Many of the waypoints mark large groupings of EST, which may help direct where to begin control efforts if desirable.

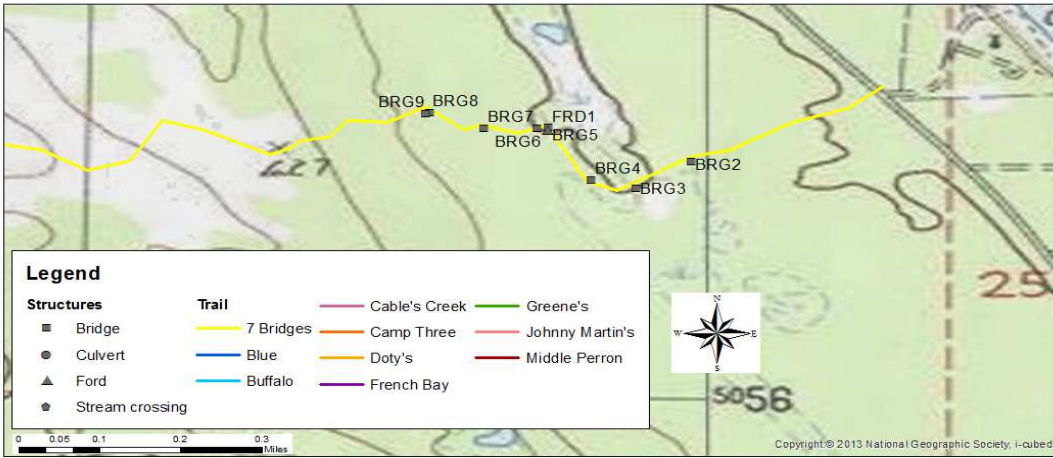
Figure 16: Structures found along the Seven Bridges Trail

The Seven Bridges Trail has eight different bridges, one of which is a foot bridge (Figure 16). A tree had fallen on BRG5 and has since been removed, but requires repair. It had appeared as though someone placed a few of the spare boards nearby next to the bridge to allow for an ATV to cross, which is marked FRD1. The other bridges were in no need of repair.

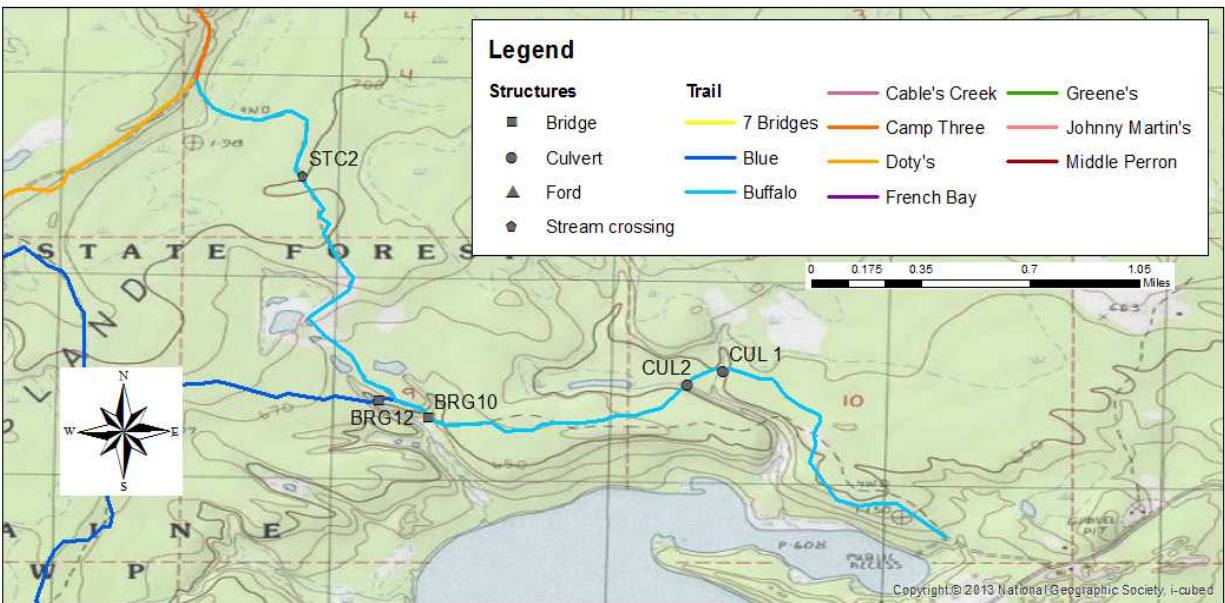
Figure 17: Structures found along the Buffalo's Camp Trail

Buffalo's Camp Trail has two culverts and one bridge, as well as one section where the trail crosses a stream (Figure 17). Both culverts are clear and undamaged; however CUL1 appears

to have some erosion. This erosion looks to have been made by someone trying to drain the low spot of the trail directly above the culvert, but this will most likely only erode more and become a larger problem. The bridge on this trail only has light cosmetic damage from an ATV. The stream crossing is past this bridge and may be fixed with a small bridge.

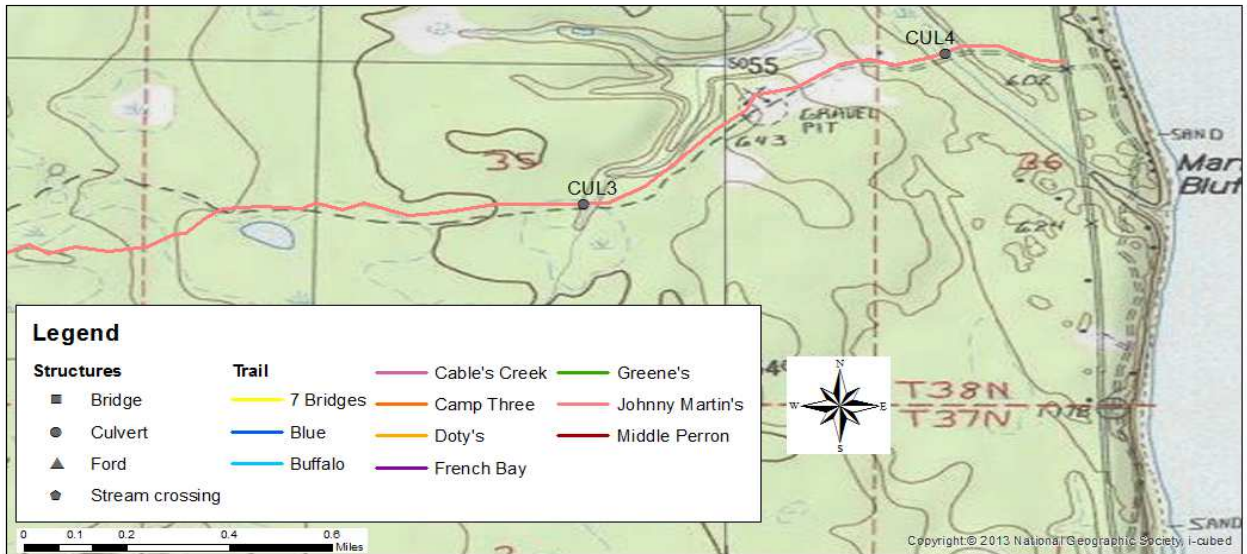
Figure 18: Structures found along the Johnny Martin's Trail

There are two culverts on Johnny Martin's Trail, one of which is located along the road, while the other is further along (Figure 18). Both are in good repair.

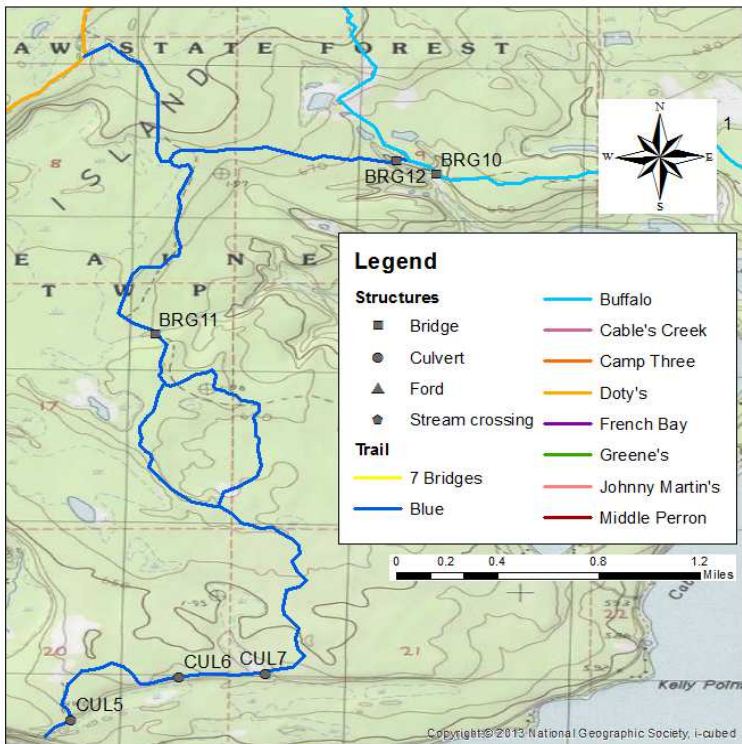
Figure 19: Structures found along the Blue Trail

The Blue Trail has two bridges, both of which are in good condition. The 100ft bridge, marked BRG11, has a few warped boards, but is passable (Figure 19). There are also three culverts on this trail. The first culvert, CUL5, is found along the gravel road leading from the main road to the parking area for the trail, and is clear and uncrushed. The remaining two culverts, CUL6 and CUL7, however, are both in bad condition. The ground around CUL6 has collapsed and obscures the culvert itself, making it difficult to see if the culvert is collapsed, rusted or plugged. The ground at both ends is wet; however, it appeared as though there was no movement of water through the culvert. CUL7 allows for a nearby wet area to drain, but has collapsed from above, making a large dip in the trail. It is possible that this culvert is made from a hollowed log, and should be replaced.

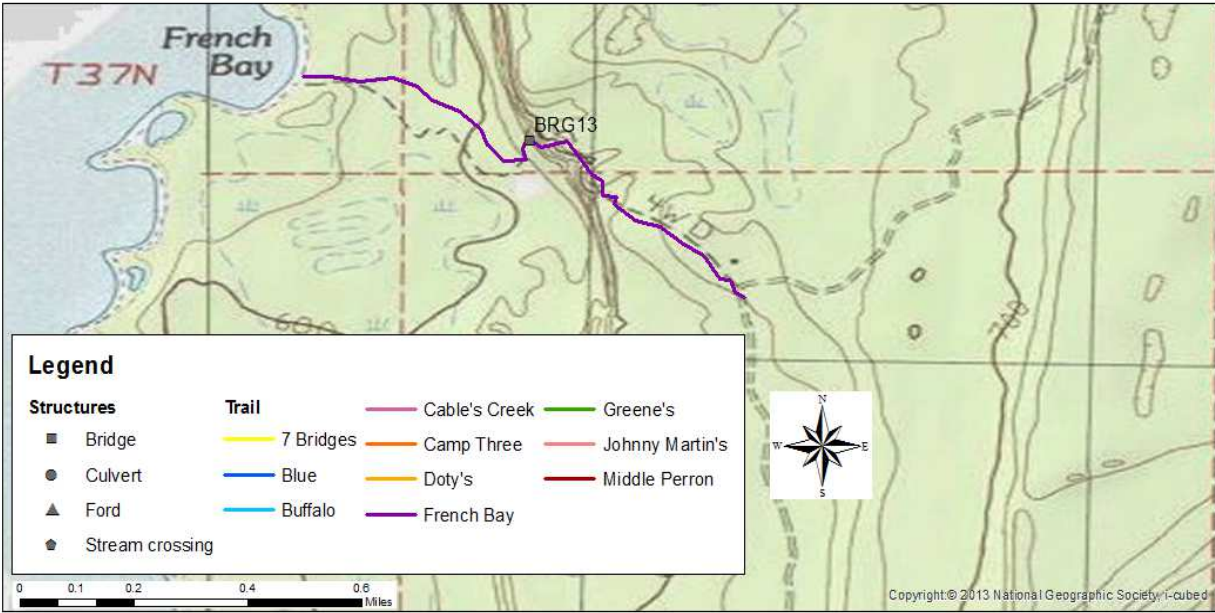
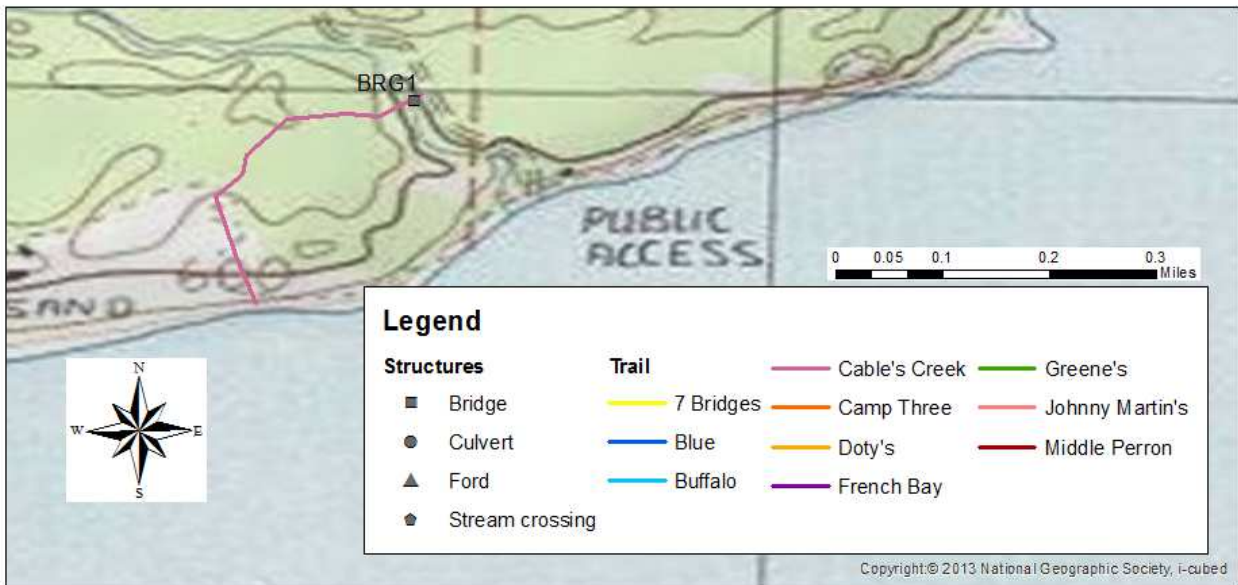
The bridges on both French Bay Road and Cable's Creek are also in good condition (Figures 20 and 21). However, there is a small occurrence of erosion at the bottom of the foot bridge on French Bay Road that should be monitored.
