Phase I Environmental Site Assessment

Approximately 183 Acres in Sections 26 and 35, Township 2 North,
Range 64 West
Keenesburg, Colorado 80643

Western Environment and Ecology, Inc.
Project Number: 754-006-01

June 3rd, 2021

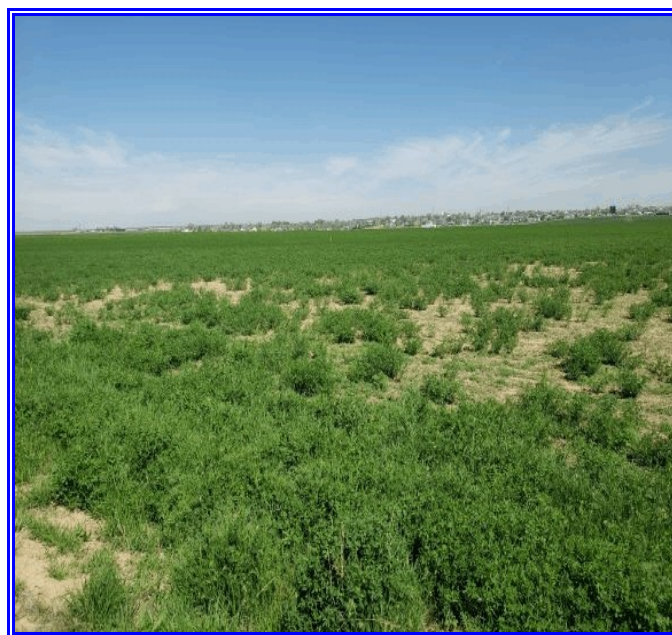
View of the property from the southeast

The subject property is located within the Town of Keenesburg, occurring to the southeast and encompassing part of County Road 16 in Weld County. At the time of the inspection the property was vacant. The majority of the site consisted agricultural areas of alfalfa (*Medicago sativa*).

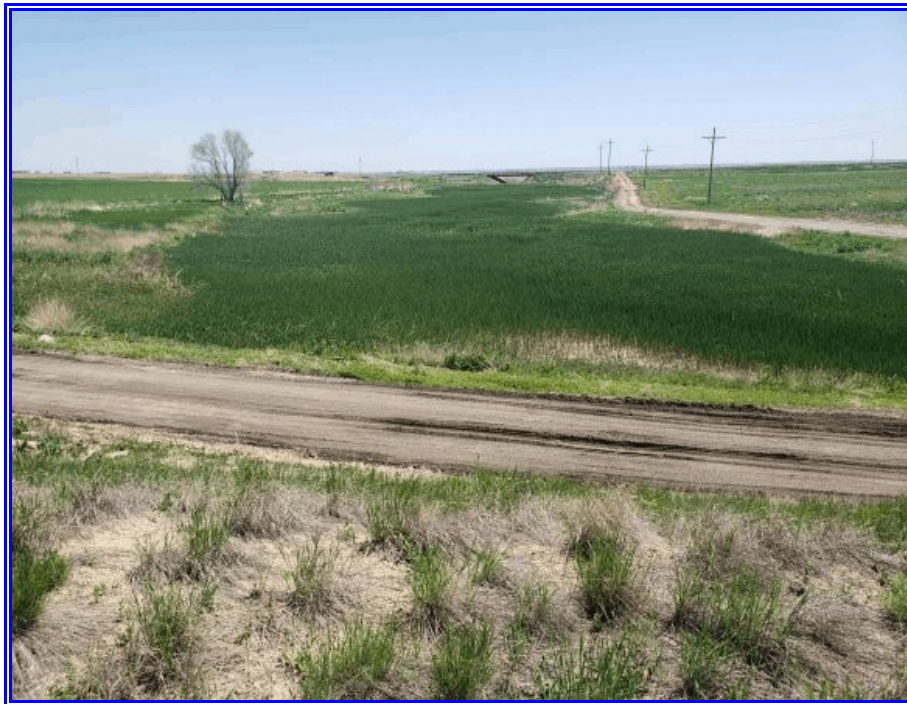
Two tributaries to Lost Creek bisect the property from the west and northwest, and confluence into Sloan Reservoir No. 1, on the northern portion of the site. A tributary to Lost Creek continues east of the reservoir and exits the property on the eastern border. Additionally, a stock pond was present on the western portion of the site. At the time of the inspection, the stock pond was dry. Unmanaged upland grasses and weeds, including alfalfa (*Medicago sativa*), western wheatgrass (*Pascopyrum smithii*), blue grama (*Bouteloua gracilis*), twoscale saltbrush (*Atriplex heterosperma*), and field sagewort (*Artemisia campestris*) surrounded the drainage. Vegetation within the aquatic resources included narrowleaf cattail (*Typha angustifolia*), curly dock (*Rumex crispus*), showy milkweed (*Asclepias speciosa*), and Nebraska sedge (*Carex nebrascensis*).

View of the eastern portion of the tributary to Lost Creek

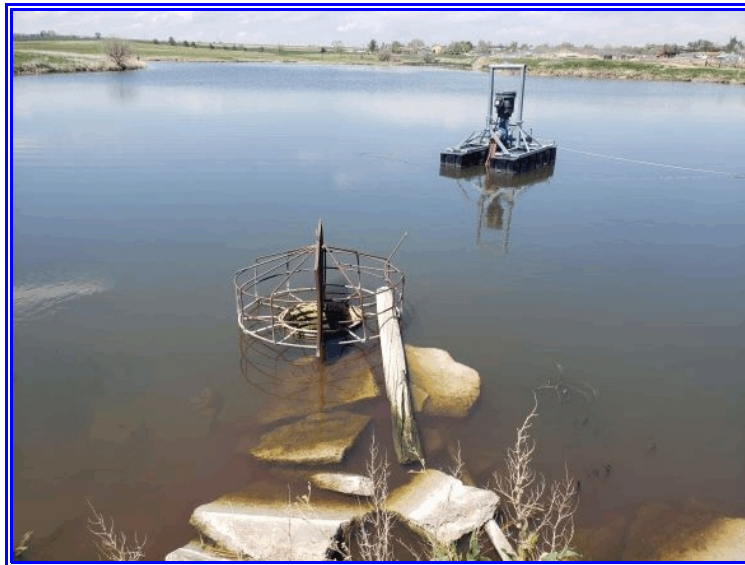
Irrigation piping and irrigataion pumps were observed within and adjacent to Sloan Reservoir No. 1, the dry stock pond, and the eastern portion of the tributary to Lost Creek. Overhead powerlines bisected the property from the east and terminated adjacent to the Sloan Reservoir No. 1. Pole mounted transformers, labeled “No PCB” were present adjacent to the Reservoir. Concrete debris was observed along the banks of the Reservoir and adjacent to the eastern portion of the tributary to Lost Creek.

View of irrigation pump in Sloan Reservoir No. 1

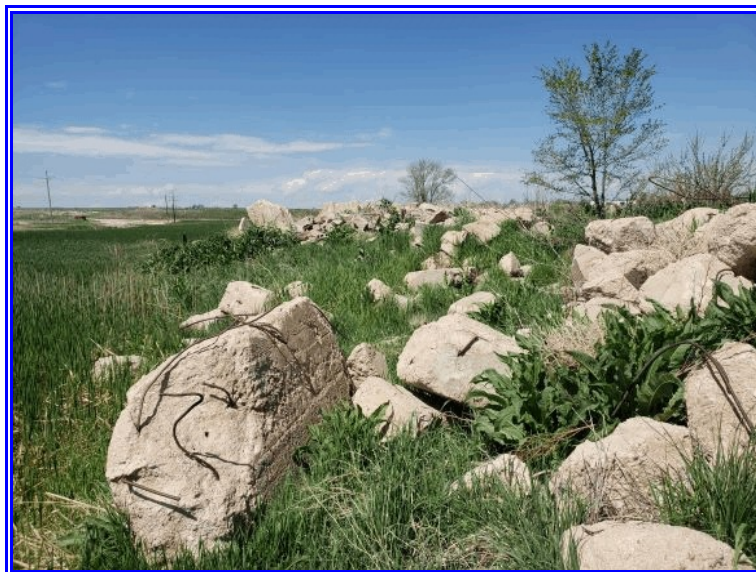
View of concrete debris

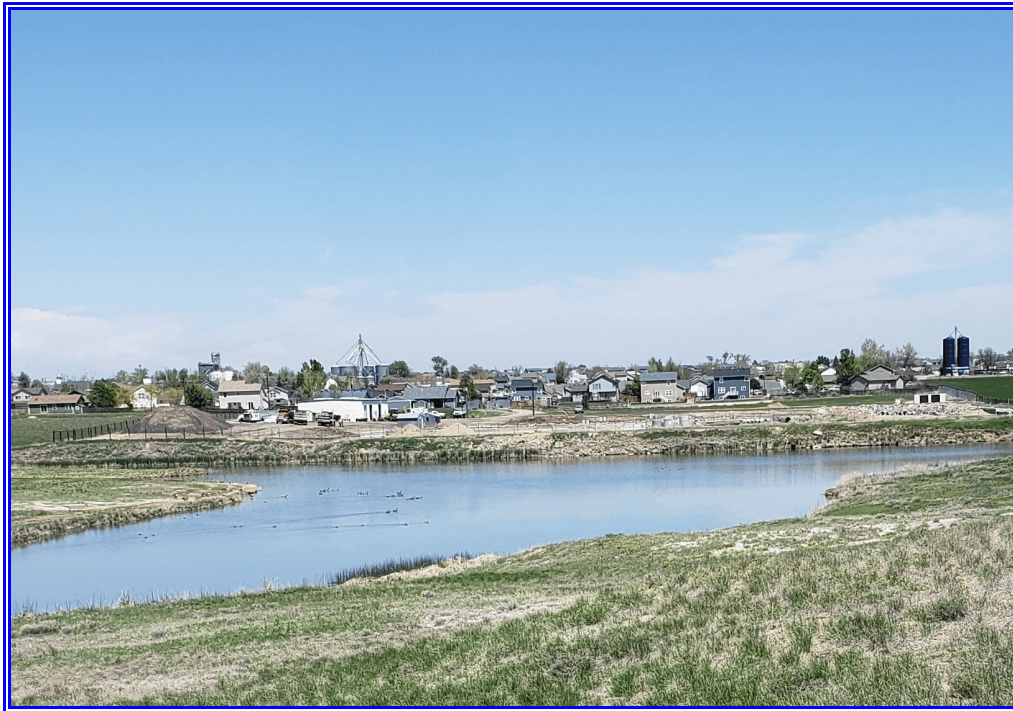
The Town Keensburg Water Treatment Plant was present adjacent to the north. A gravel access road to the Plant bisected the property from the east. Construction activity, including the placement of fill material, was observed at the Plant. Stormwater runoff from the plant flow into the Sloan Reservoir No. 1. Additionally, effluent from the Plant is discharged into the Reservoir.

View of Town of Keensburg Wastewater Treatment Plant
