Michigan DNR Trails Inventory on Beaver Island Summer of 2016 Report

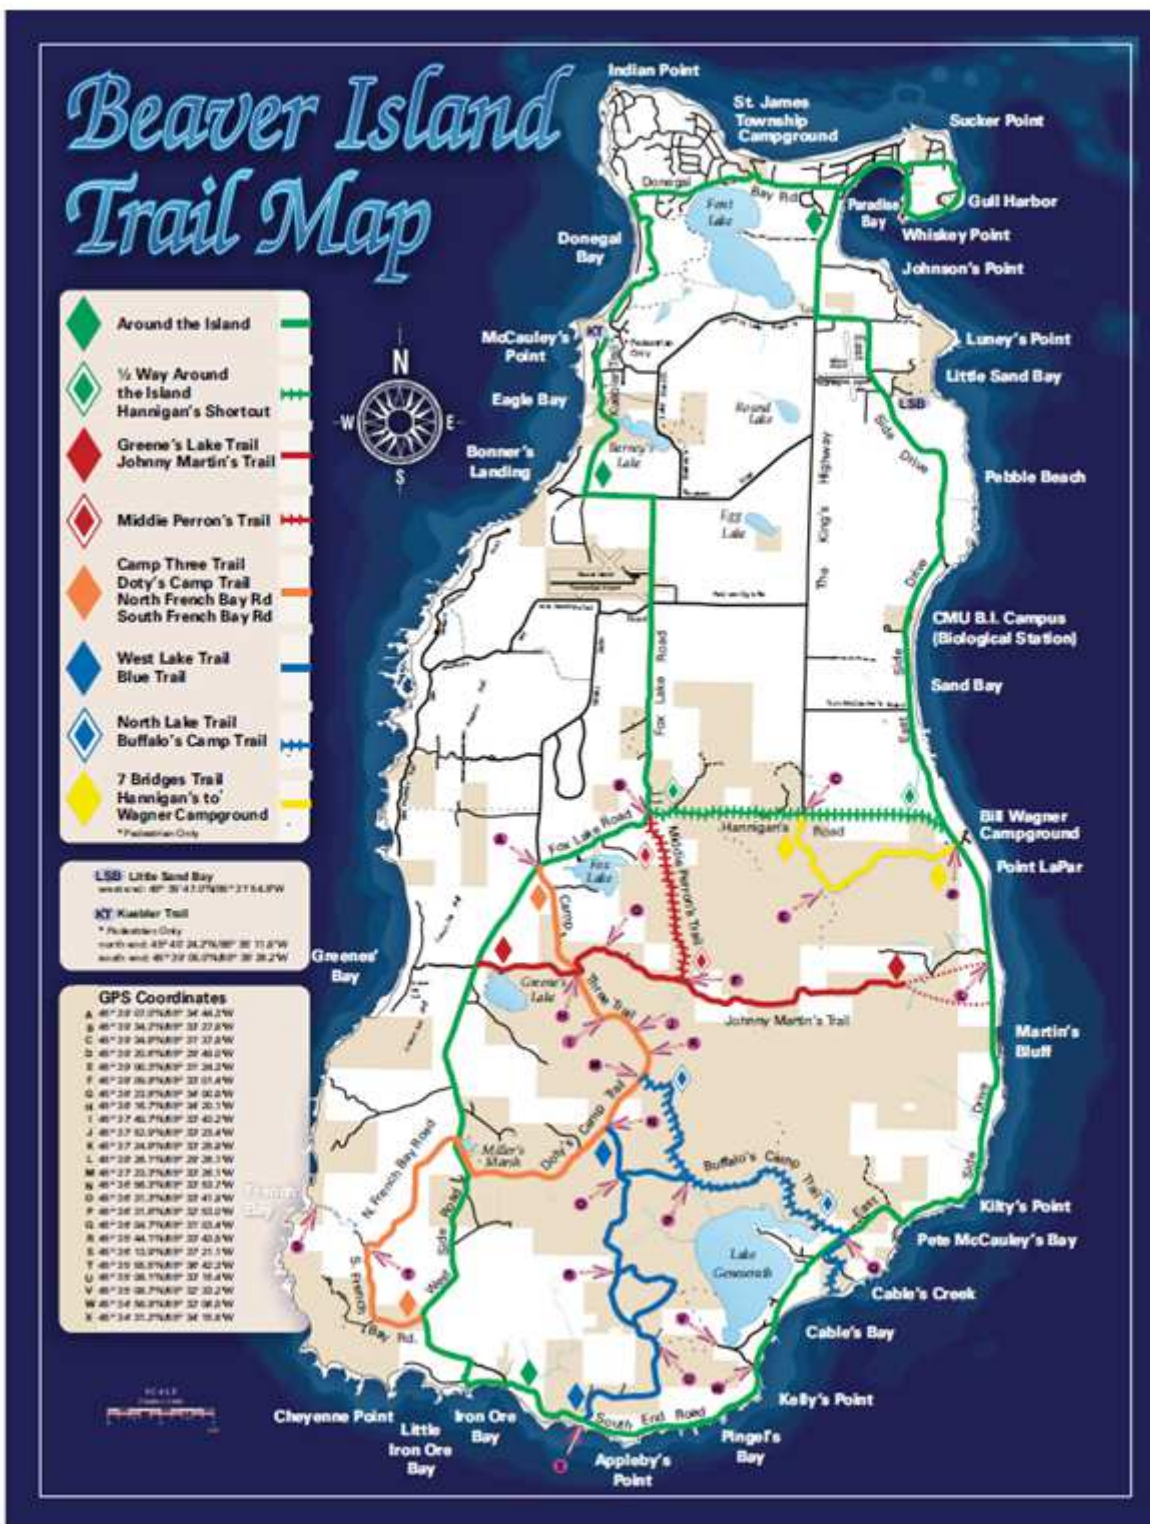
Figure 1: Trail map used for reference

There is some disagreement between the color of trail markers and color of trails on the trail map used for reference (Figure 1). Blue and orange markers are on the trails, but not necessarily along the trails labeled blue and orange on the map.

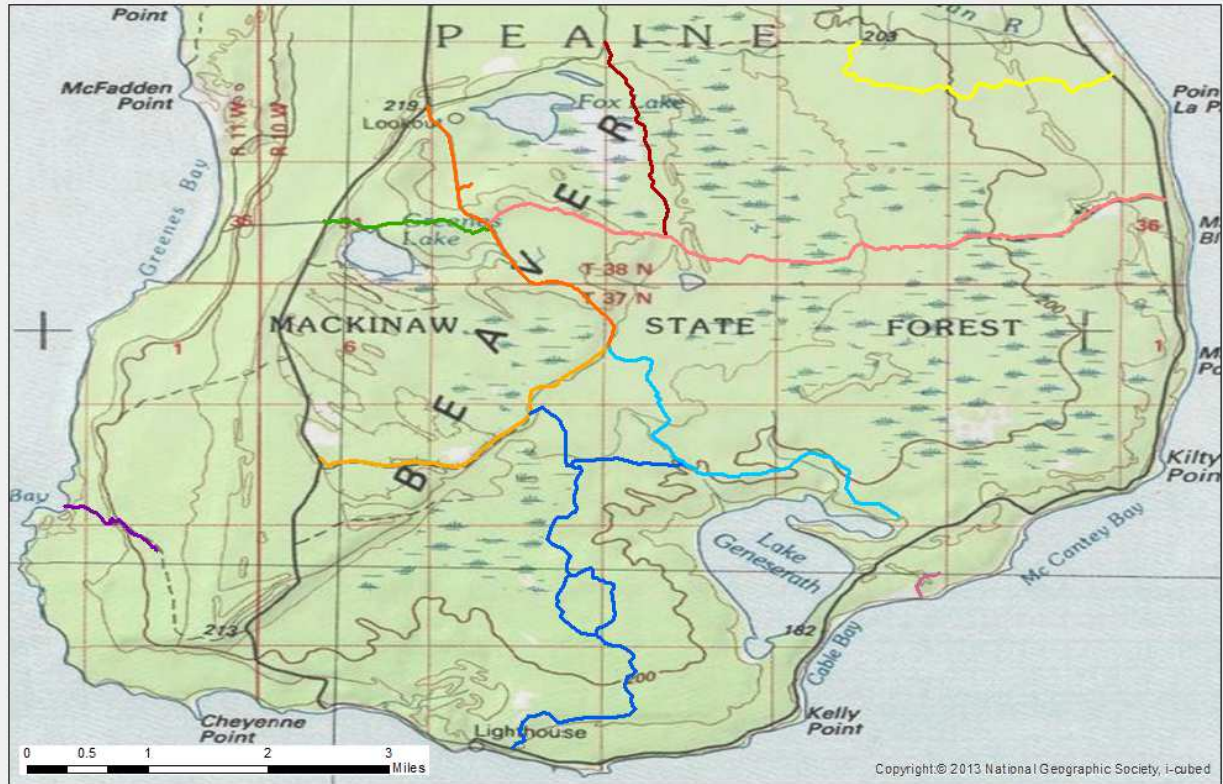
Figure 2: Trail map created in 2016.

Trails were walked and tracked using GPS to mark their locations (Figure 2). Many trails had fallen trees blocking the path, or needed trimming of limbs or stick removal. After a period of high wind, it was not uncommon to have newly fallen trees on trails that had already been cleared. Certain trails have patches of abundant berry bushes, and these areas may need to be trimmed back every couple of years to prevent the bushes from taking over the trail. Sections further along the trails, especially on Blue Trail and Johnny Martin's Trail, were overgrown with grasses, ferns, and young woody shrubs. This is most likely due to infrequent use, but if left untrimmed may fill in and become difficult to pass. The use of brush hogs, weed-whackers, or other equipment may prove helpful at maintaining these sections if used every few years to keep shrubs and other large plants from establishing and blocking the path. Many of the trails were adequately marked; however, both the Seven Bridges Trail and Johnny Martian's Trail needed some marking which was completed. Several problem areas were encountered on the various trails (Figure 3). The most common problem areas were large muddy permanent puddles that either blocked maintenance vehicles or foot traffic. Ruts were also common and often muddy. Occasionally, wet areas had small workarounds, but these side paths had also been used by vehicles, which created new ruts and areas for water to pool.

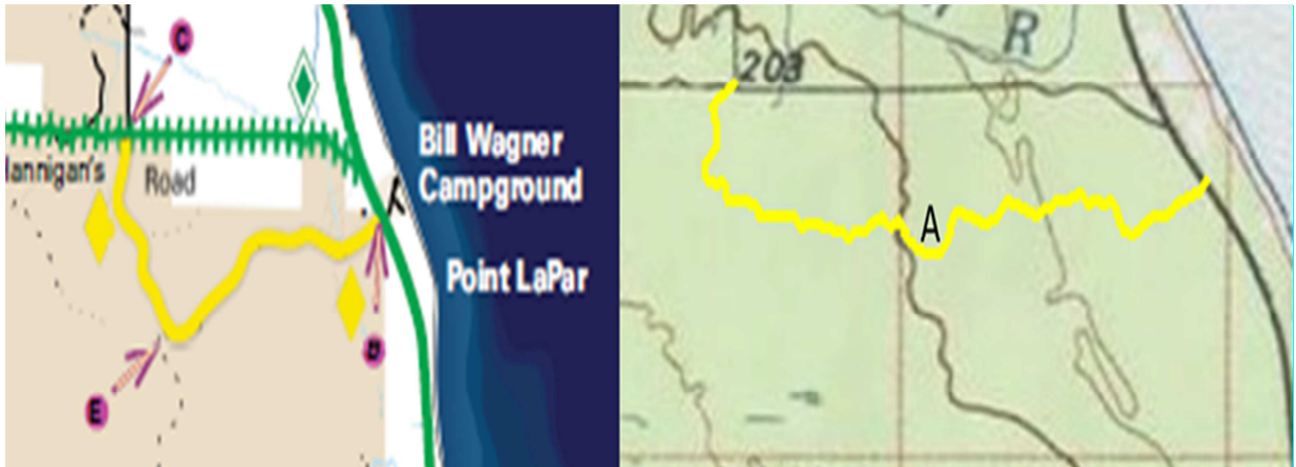
Figure 5: Seven Bridges Trail modification based on inventory

Starting from the end closest to the Bill Wagner Campground, the Seven Bridges Trail has few issues (Figure 4). There are some posts that are missing the small eagle markers, but the trail is easy to follow. PA6 is a stand of woody young plants that blocks the trail; however, someone has since cleared a path around this stand to continue on the trail. Similar clearing once a year may help keep the stand from taking over this part of the trail. At the opposite end, the start of the trail is very swampy and easy to lose. This swampy portion stretches between PA3 and PAH4, and may be fixed through a series of slightly raised foot bridges or boardwalks. Note: PAH5 was a group of leaning trees that has since been removed. Orange paint was used to mark areas where the trail was easily lost and to delineate a section of trail that was created prior to this project (Figure 5).
